AIRPROX REPORT No 2021084

Date: 15 Jun 2021 Time: 1111Z Position: 5254N 00050W Location: Barkestone-le-Vale

PART A: SUMMARY OF INFORMATION REPORTED TO UKAB

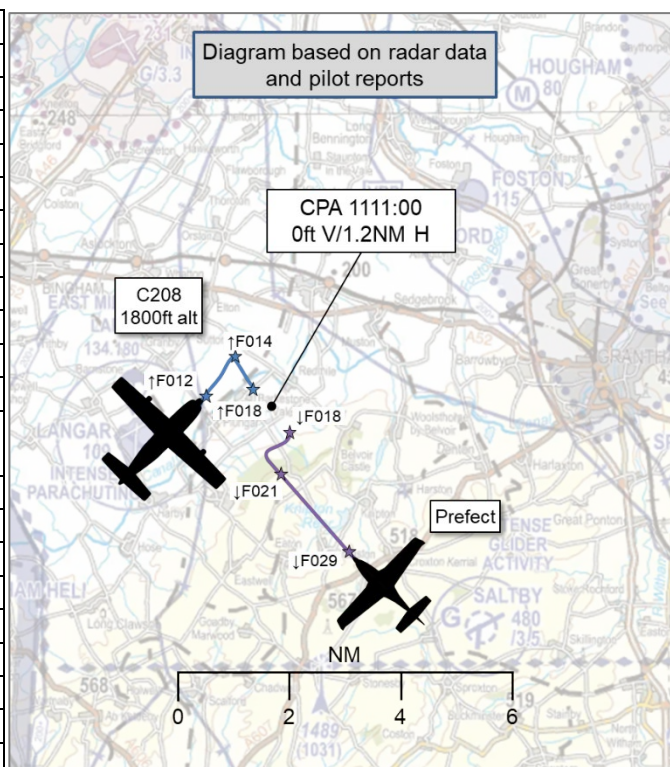
THE C208 PILOT reports that they were departing Langar to climb onto the run-in, which was 340°, for a 3500ft drop with 15 passengers on board. As they turned back to Langar at 1500ft the TCAS alerted them to a fast-moving aircraft descending and heading towards them. They maintained heading and the aircraft was still coming towards them and descending to their level, so they levelled off to avoid conflict. The aircraft was flying very fast at a high rate of descent, very close to the Langar Drop zone from where they were operating.

The pilot assessed the risk of collision as 'High'.

THE PREFECT PILOT reports that they submitted the DASOR in response to an Airprox raised. They remember the incident which occurred during the instrument recovery at the end of a QFI Check ride. They were receiving radar vectors from Cranwell App and were being vectored to the east of Langar Para-dropping site which was active. As they passed abeam Langar, ATC informed them of traffic in the 11 o'clock and gave them a vector that took them away from the traffic and towards BKH which was the airfield they were recovering to. They saw the aircraft at 0.5NM, straight away and, as it was below and turning west away from them, did not perceive any risk. They were surprised to hear that the para-dropping aircraft had raised an Airprox.

The pilot assessed the risk of collision as 'Low'.

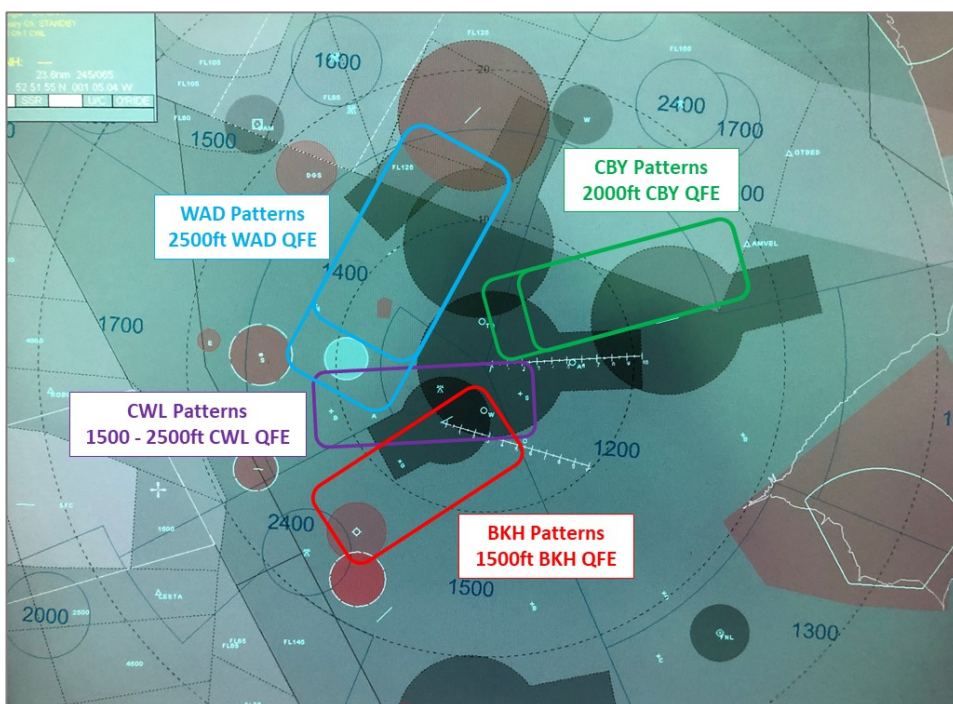
Figure 10: Cranwell radar map depicting radar patterns and local restrictions

The actions of the Cranwell controller were executed as expected for the situation. Whilst Traffic Information is normally expected to be passed by 5NM if it is anticipated that the aircraft are going to get within 3NM of each other, in this situation the controller was providing identification and more time-pressing Traffic Information to another aircraft. The C208 was initially tracking NE whilst climbing and the timely Traffic Information from ATC allowed the Prefect to become visual. The C208 pilot turned left to an eventual SW heading which decreased the separation between the two aircraft. It is also unfortunate that the C208 was not in receipt of an ATS therefore were unable to be made aware that the Prefect was visual with them.

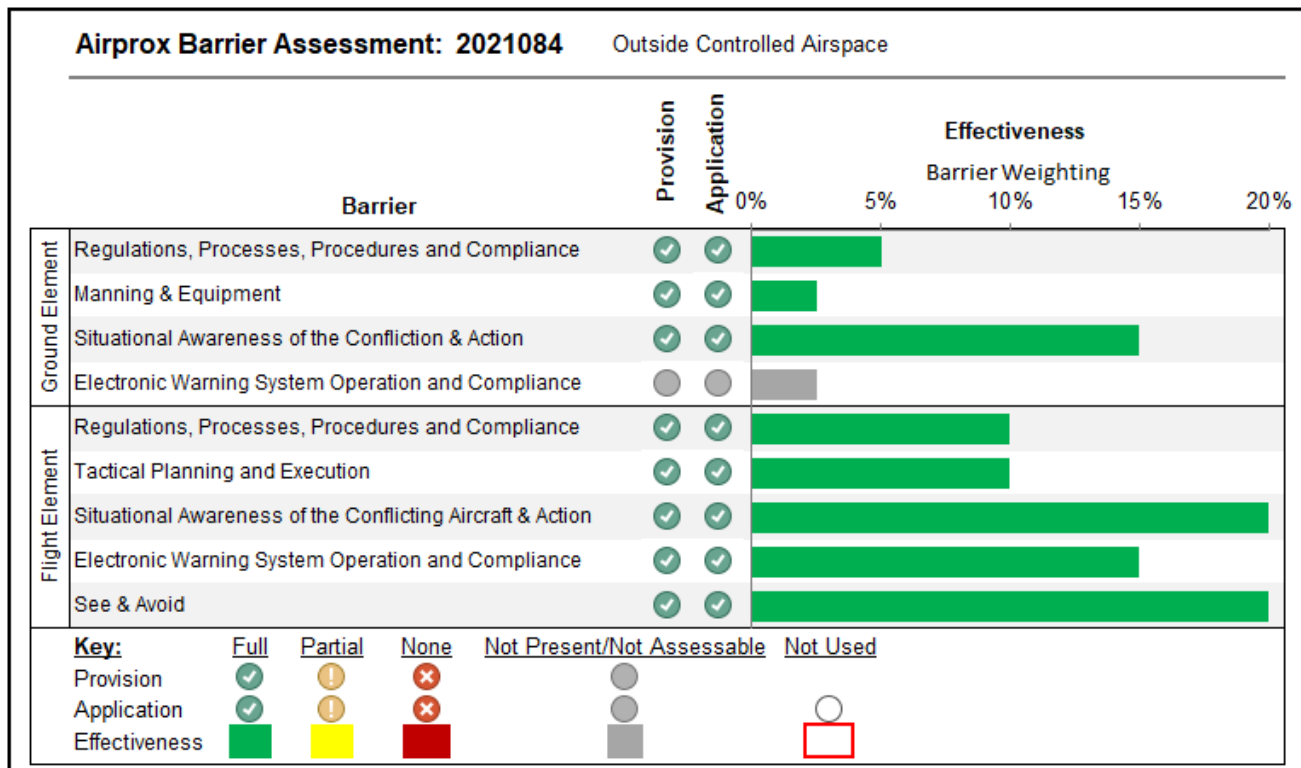
Safety Barrier Assessment³

In assessing the effectiveness of the safety barriers associated with this incident, the Board concluded that the key factors had been that all the barriers worked as expected.
