AIRPROX REPORT No 2021098

Date: 26 Jun 2021 Time: ~1003Z Position: 5206N 00005E Location: Fowlmere/Duxford circuits

PART A: SUMMARY OF INFORMATION REPORTED TO UKAB

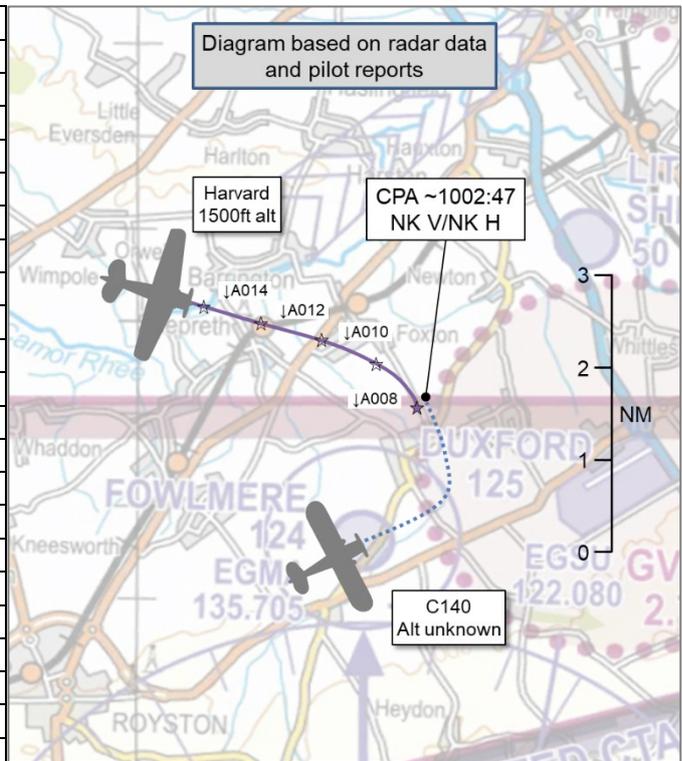
THE C140 PILOT reports that, before walking to the aircraft, they called Duxford ATC by telephone to inform them about planned circuit training on RW07LH at Fowlmere, also stating that they would make radio contact to confirm after getting airborne (due bad radio reception on the ground). This was all acknowledged by Duxford ATC. They took-off and called Duxford ATC, who acknowledged their information call and, just after turning crosswind, they noticed a Harvard approaching them on their left (inside the circuit) at the same height, opposite direction and quite close. It was not visible to them previously due to their flying a high-wing aircraft. They did not take any actions apart from monitoring the Harvard’s movements.
