AIRPROX REPORT No 2021199

Date: 15 Sep 2021 Time: 1222Z Position: 5214N 00252W Location: Shobdon

An Airprox was reported when a C42 and a Tecnam flew into proximity in the Shobdon visual circuit at 1222Z on Wednesday 15th September 2021. Both pilots were operating under VFR in VMC, both were in receipt of an AFIS from Shobdon.

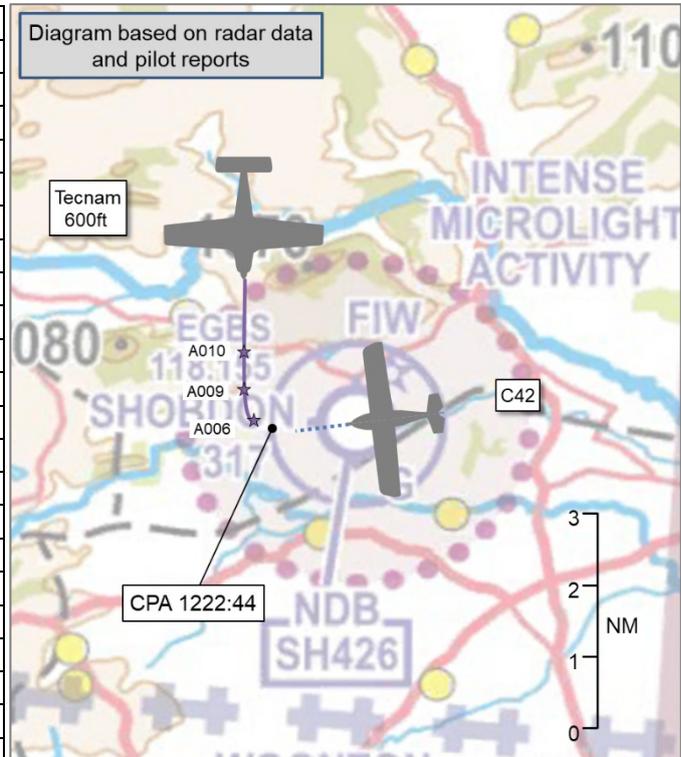
THE C42 PILOT reports that at approximately 1330 local time they were circuit training with a fixed wing student, performing touch and go's on RW26 left hand. They were flying a white Ikarus C42 microlight. The weather was good with good visibility. On their third to last circuit they were aware that the pilot of [Tecnam C/S] was approaching from the north and had requested a crosswind join for RW26. Throughout their approach, touch and go and climb-out, they kept a good lookout for the aircraft they anticipated seeing moving right to left joining crosswind at 1000ft. At 400ft on climb-out they caught sight of the aircraft turning left directly towards them at approximately 600ft. The pilot appeared to have turned final for RW08. They pressed the PTT button and said along the lines of "I have visual, the aircraft is coming towards us." They said this to warn the FISO and pilot in the converging aircraft. They briefly took control of the C42 and turned right 20° to avoid a potential collision. The pilot of the converging aircraft, announced over the radio "I'm sorry I've got disorientated" or something similar and then the pilot turned to their right. The C42 pilot delayed turning crosswind until they could see the aircraft climbing away from the circuit. They continued to fly two more circuits on RW26, aware that the pilot of [Tecnam C/S] had announced they were going to re-join overhead. They observed the Tecnam join overhead, however it descended incorrectly and didn't appear to fly the correct main circuit pattern.
