AIRPROX REPORT No 2021208

Date: 10 Oct 2021 Time: 0842Z Position: 5249N 00144W Location: Tatenhill

PART A: SUMMARY OF INFORMATION REPORTED TO UKAB

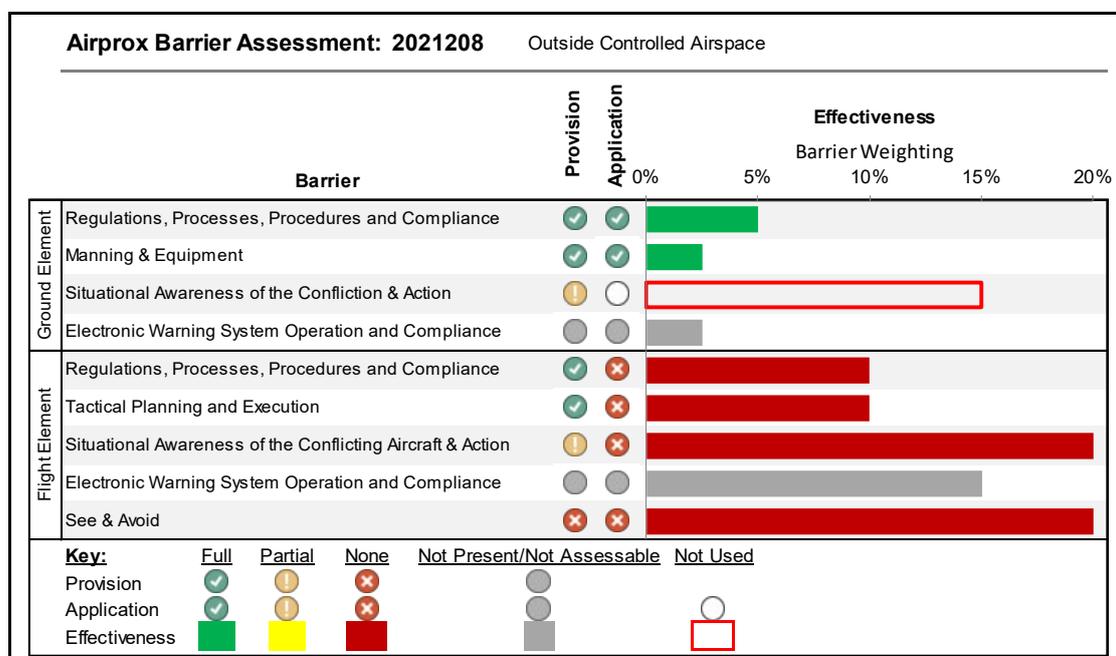
Situational Awareness of the Conflicting Aircraft and Action were assessed as **ineffective** because neither pilot had any prior situational awareness that the other was in the immediate vicinity.

See and Avoid were assessed as **ineffective** because neither pilot saw the other aircraft until after the Airprox.
