AIRPROX REPORT No 2021231

Date: 12 Nov 2021 Time: 1131Z Position: 5237N 00027W Location: Wittering ATZ

PART A: SUMMARY OF INFORMATION REPORTED TO UKAB

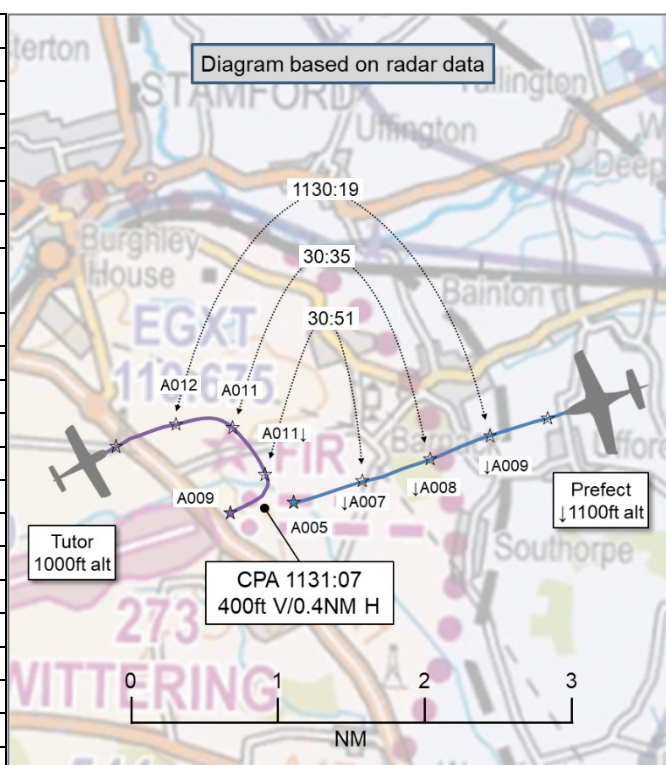
THE PREFECT PILOT reports that during a PAR to RW25 on the Talkdown frequency, with the student in the right-hand seat head-in flying the approach, they were cleared for a low approach not below 200ft, which was read back by the student. At approximately 400ft they spotted a Tutor to their right, half past 1 o'clock, high and the [compatible EC equipment] audio sounded. The Tutor was approximately 600m away and closing, turning final and descending in front of them. As the student approached decision-height at 240ft the TAS traffic alert sounded as the Tutor crossed in front to the dead side with closest approach estimated at approximately 300m and at the same level. Avoiding action was not taken as they were unsure if the Tutor pilot had Situational Awareness on them, so, with a desire to remain predictable, they elected to let the student fly the planned missed approach heads in, whilst they maintained sight of the Tutor. The student flew the planned missed approach and began climbing away from decision height at 240ft while the tutor continued onto the deadside approximately 400m in front. As they began to climb away the tutor turned cross wind in front of them and they lost sight as it passed below the nose. With maximum-continuous power set and at maximum rate of climb they were content this was the safest course of action to create separation from the Tutor. They then changed to the Approach frequency and reported an Airprox, with the rest of the sortie continuing without further incident.

THE TUTOR PILOT reports that they were the handling pilot and, after completing a go-around from a PAR approach, they had joined the visual circuit at 800ft on the deadside. Tower called them stating "radar traffic, 7 miles", therefore they called "extending upwind" and did so before turning downwind. They called "downwind to land" at the usual position and Tower informed them that the radar traffic was now at 5NM. As a result, when abeam the threshold they called "going around at circuit height, with radar traffic in sight". Once positioned deadside at 800ft and at 80kts they requested an update on the

location of the radar traffic. ATC stated "*radar traffic over the ramp*". They became visual with the radar traffic in their 5 o'clock and turned downwind, They remained visual with the Prefect throughout the downwind turn. When they were perpendicular to the runway they could see the Prefect on their right-hand side with safe separation. They continued and landed as normal. During the in-brief they were advised that the Prefect pilot had filed an Airprox.

They recall that they were ahead of the Prefect during the go-around and their downwind turn, maintaining Situational Awareness of the Prefect and other traffic in the visual circuit at all times. Separation was maintained throughout and they were visual with the Prefect before, during and after the downwind turn. At no point did they consider the separation to be unsafe for the visual circuit.
