**AIRPROX REPORT No 2021245**

Date: 15 Dec 2021 Time: 1336Z Position: 5340N 00032W Location: 6NM NE Scunthorpe

**PART A: SUMMARY OF INFORMATION REPORTED TO UKAB**

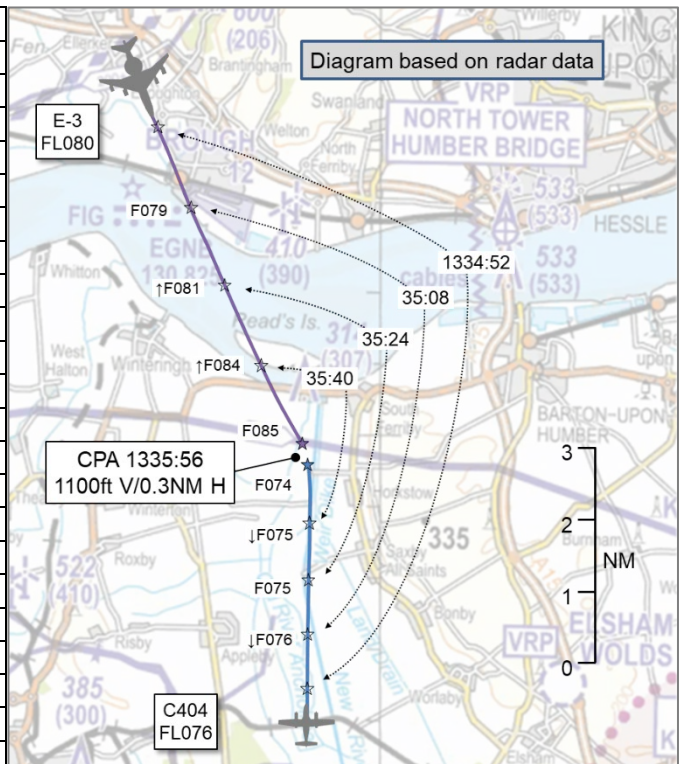
Recorded	Aircraft 1	Aircraft 2
Aircraft	C404	E-3
Operator	Civ Comm	HQ Air (Ops)
Airspace	London FIR	London FIR
Class	G	G
Rules	VFR	Unknown
Service	Traffic	Traffic
Provider	Humberside Radar	Waddington Radar
Altitude/FL	FL074	FL085
Transponder	A, C, S	A, C, S
<b>Reported</b>		
Colours	White, Blue	NR
Lighting	Anti-cols, Nav	NR
Conditions	VMC	VMC
Visibility	>10km	NR
Altitude/FL	8000ft	NR
Altimeter	QNH (NK hPa)	Std (1013hPa)
Heading	360°	NK
Speed	165kt	NK
ACAS/TAS	Not fitted	TCAS II
Alert	N/A	Unknown
<b>Separation at CPA</b>		
Reported	600-700ft V/1NM H	NK V/NK H
Recorded	1100ft V/0.3NM H
