**AIRPROX REPORT No 2021018**

Date: 30 Mar 2021 Time: 1618Z Position: 5309N 00237W Location: 7NM NW of Crewe

**PART A: SUMMARY OF INFORMATION REPORTED TO UKAB**

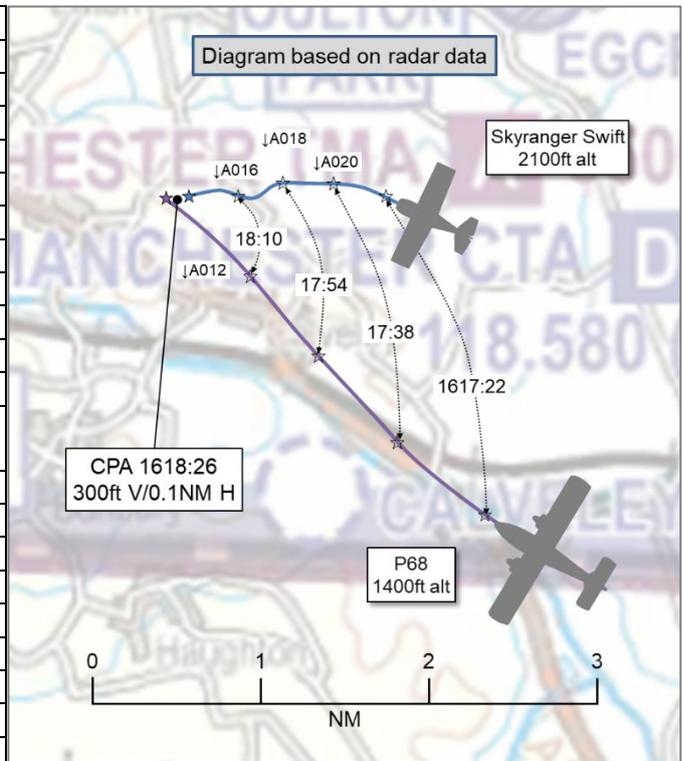
Recorded	Aircraft 1	Aircraft 2
Aircraft	Skyranger Swift	P68
Operator	Civ FW	Civ Comm
Airspace	London FIR	London FIR
Class	G	G
Rules	VFR	VFR
Service	None	None
Provider	N/A	N/A
Altitude/FL	FL012	FL009
Transponder	A, C, S	A, C, S
<b>Reported</b>		
Colours	Orange	White/blue
Lighting	Strobes, landing	Nav, anti-coll, strobes
Conditions	VMC	VMC
Visibility	100NM	>10km
Altitude/FL	1175ft	1500ft
Altimeter	NR	NK
Heading	NR	NK
Speed	63kt	120kt
ACAS/TAS	PilotAware	Not fitted
Alert	None	N/A
<b>Separation</b>		
Reported	200ft V/20m H	200ft V/<0.5NM H
Recorded	300ft V/0.1NM H
