**AIRPROX REPORT No 2021053**

Date: 11 May 2021 Time: 1348Z Position: 5113N 00005E Location: 4NM NE of Lingfield

**PART A: SUMMARY OF INFORMATION REPORTED TO UKAB**

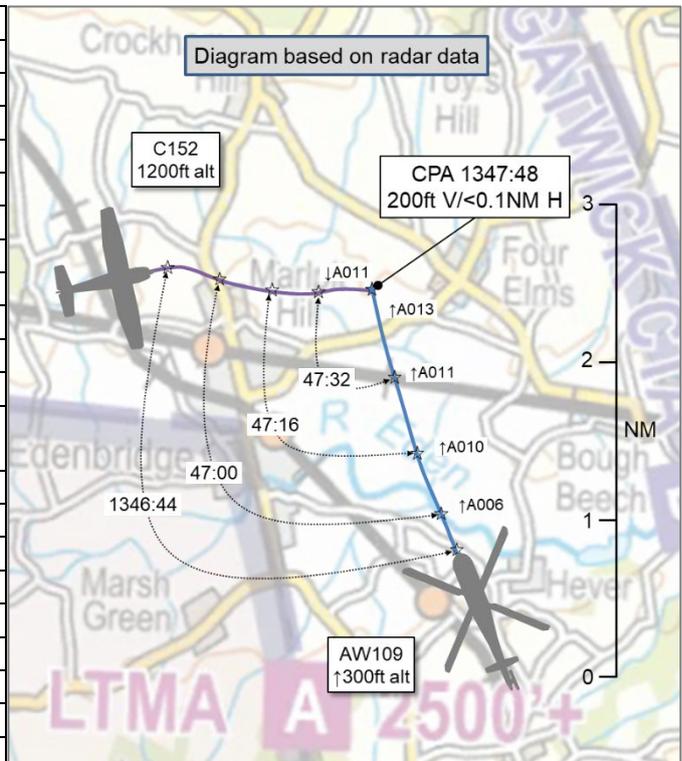
Recorded	Aircraft 1	Aircraft 2
Aircraft	AW109SP	C152
Operator	Civ Helo	Civ FW
Airspace	London FIR	London FIR
Class	G	G
Rules	VFR	VFR
Service	Basic	None <sup>1</sup>
Provider	Biggin Hill App	Farnborough LARS
Altitude/FL	A013	A011
Transponder	A, C, S	A, C, S
<b>Reported</b>		
Colours	Grey, red	Silver
Lighting	Strobes, anti-colls, nav, landing lights	Beacon, nav lights
Conditions	VMC	VMC
Visibility	>10km	NR
Altitude/FL	1400ft	1200ft
Altimeter	QNH (1007hPa)	QNH
Heading	335°	NR
Speed	135kt	NR
ACAS/TAS	TAS	Not fitted
Alert	TA	N/A
<b>Separation</b>		
Reported	20ft V/0NM H	NR V/NR H
Recorded	200ft V/<0.1NM H

**THE AW109 PILOT** reports that shortly after lifting from a landing site near Hever Castle, they were making an RT call to Biggin Hill to establish an ATZ crossing and they saw a fixed-wing aircraft low and left, within 2-5sec it had passed underneath them at about 20-50ft below. No avoiding action was taken as there was too little time. The aircraft was blocked by their cockpit console and, they believe, being a high wing fixed-wing, the pilot would not have seen them. They were in a high workload section of their flight, having just lifted and trying to get airspace crossing approval at short notice. The low Gatwick airspace limit in conjunction with high ground in the area is a contributing factor as there is a narrow margin for Class G transit. There was no risk of collision, however, the margins were quite small.
