AIRPROX REPORT No 2020006

Date: 21 Jan 2020 Time: 1412Z Position: 5051N 00009W Location: Brighton

PART A: SUMMARY OF INFORMATION REPORTED TO UKAB

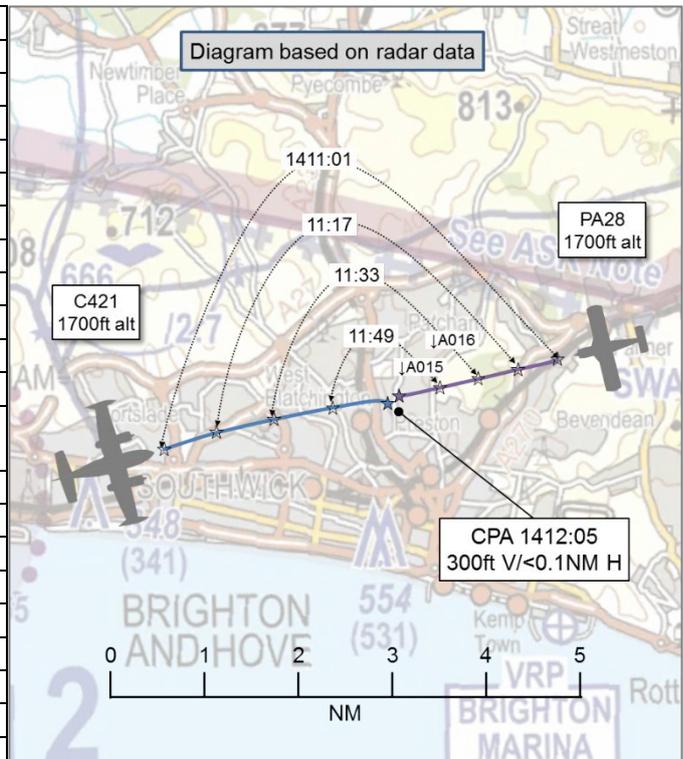
| Recorded | Aircraft 1 | Aircraft 2 |
|---|---|---|
| Recorded | 300ft V/<0.1NM H | |

In considering the collision risk of this encounter, the Board felt that the lack of Traffic Information had played a crucial part in allowing the 2 aircraft to fly into proximity but, without a controller's report, it had not been possible to establish why the passage of Traffic Information had been so late. Members were heartened to hear that the CAA will be conducting a review of reporting requirements of ANSPs as part of the post-Brexit regulatory environment. Nevertheless, the Board agreed that, although safety had been degraded, the PA28 pilot had sighted the C421 early enough to remove any risk of collision; Risk Category C.
