**AIRPROX REPORT No 2020022**

Date: 19 Feb 2020 Time: 1112Z Position: 5152N 00034W Location: 1NM W Dunstable Downs GS

**PART A: SUMMARY OF INFORMATION REPORTED TO UKAB**

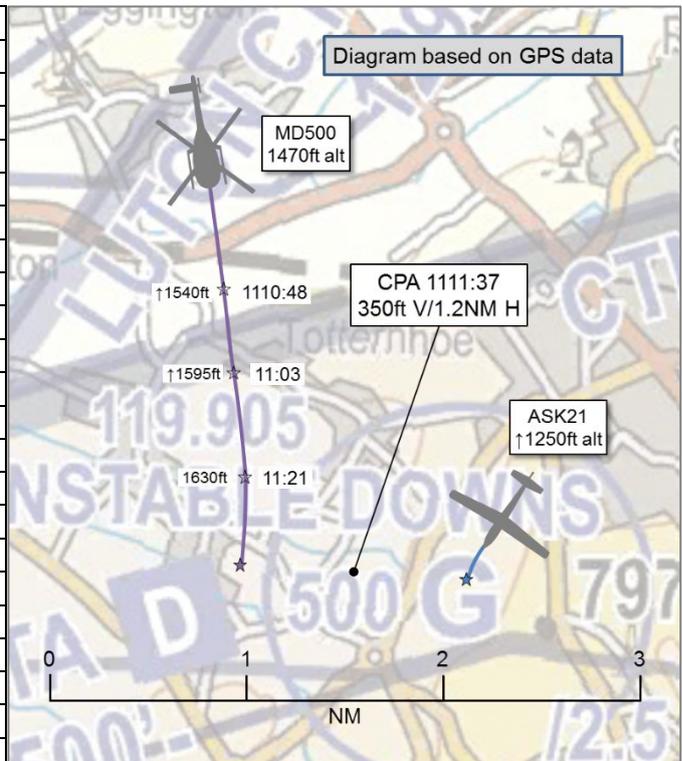
Recorded	Aircraft 1	Aircraft 2
Aircraft	ASK21 Glider	MD500
Operator	Civ Gld	Civ Helo
Airspace	Luton CTR	Luton CTR
Class	D	D
Rules	VFR	VFR
Service	AGCS	Radar Control
Provider	Dunstable Radio	Luton INT
Altitude/FL	1257ft	1618ft
Transponder	Not fitted	A C, S
<b>Reported</b>		
Colours	White/Red	Blue/White
Lighting	None	NR
Conditions	VMC	VMC
Visibility	>10km	NR
Altitude/FL	1000ft	1500ft
Altimeter	QFE	QNH (1020hPa)
Heading	220°	NR
Speed	75kt	NR
ACAS/TAS	Not fitted	Not fitted
<b>Separation</b>		
Reported	200ft V/500m H	1000ft V/1.5NM H
Recorded	360ft V/1.2NM H
