**AIRPROX REPORT No 2020076**

Date: 22 Jul 2020 Time: 1447Z Position: 5104N 00230W Location: 6NM NE Yeovilton

**PART A: SUMMARY OF INFORMATION REPORTED TO UKAB**

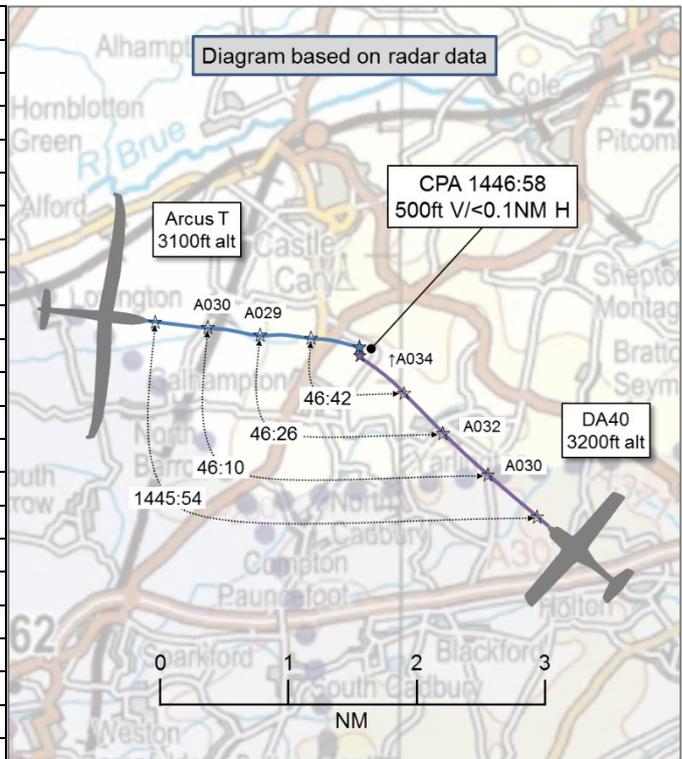
Recorded	Aircraft 1	Aircraft 2
Aircraft	Arcus T	DA40
Operator	Civ Gld	Civ FW
Airspace	London FIR	London FIR
Class	G	G
Rules	VFR	VFR
Service	Basic	Basic
Provider	Yeovilton LARS	Yeovilton LARS
Altitude/FL	2900ft	3400ft
Transponder	A, C, S	A, C, S
<b>Reported</b>		
Colours	White/red	White
Lighting	NR	NR
Conditions	VMC	VMC
Visibility	NR	>10Km
Altitude/FL	3200ft	NR
Altimeter	QNH (1025hPa)	NR
Heading	NR	NR
Speed	70kt	NR
ACAS/TAS	PowerFLARM	TAS
Alert	None	Unknown
<b>Separation</b>		
Reported	NR V/0m H	Not Seen
Recorded	500ft V/<0.1NM H
