## AIRPROX REPORT No 2020109

Date: 05 Sep 2020 Time: 1224Z Position: 5208N 00027E Location: 3NM N of Haverhill

### PART A: SUMMARY OF INFORMATION REPORTED TO UKAB

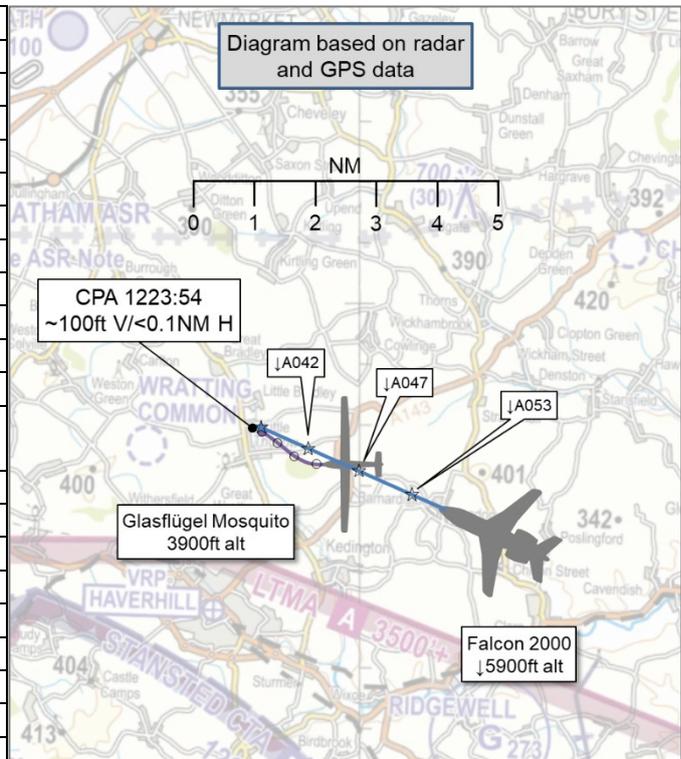
Recorded	Aircraft 1	Aircraft 2
Aircraft	Falcon 2000	Glasflügel Mosquito
Operator	Civ Comm	Civ Gld
Airspace	London FIR	London FIR
Class	G	G
Rules	IFR	IFR <sup>1</sup>
Service	Procedural <sup>2</sup>	None
Provider	Cambridge	N/A
Altitude/FL	4000ft	3900ft
Transponder	A, C, S	Not fitted
<b>Reported</b>		
Colours	White	White/Red
Lighting	Strobes, nav, landing lights	Nil
Conditions	VMC <sup>1</sup>	VMC <sup>1</sup>
Visibility	20km	10km
Altitude/FL	4000ft	3500ft
Altimeter	QNH (1020hPa)	QFE
Heading	285°	300°
Speed	220kt	55kt
ACAS/TAS	TCAS II	Not fitted
Alert	None	N/A
<b>Separation</b>		
Reported	0ft V/100m H	0ft V/200m H
Recorded	~100ft V/<0.1NM H <sup>3</sup>

<sup>3</sup> Recorded CPA measured by comparing radar data from the SSR responses of the Falcon 2000 with the GPS data supplied by the pilot of the Glasflügel Mosquito.
