AIRPROX REPORT No 2020126

Date: 18 Sep 2020 Time: 1123Z Position: 5144N 00010E Location: North Weald – elev 321ft

PART A: SUMMARY OF INFORMATION REPORTED TO UKAB

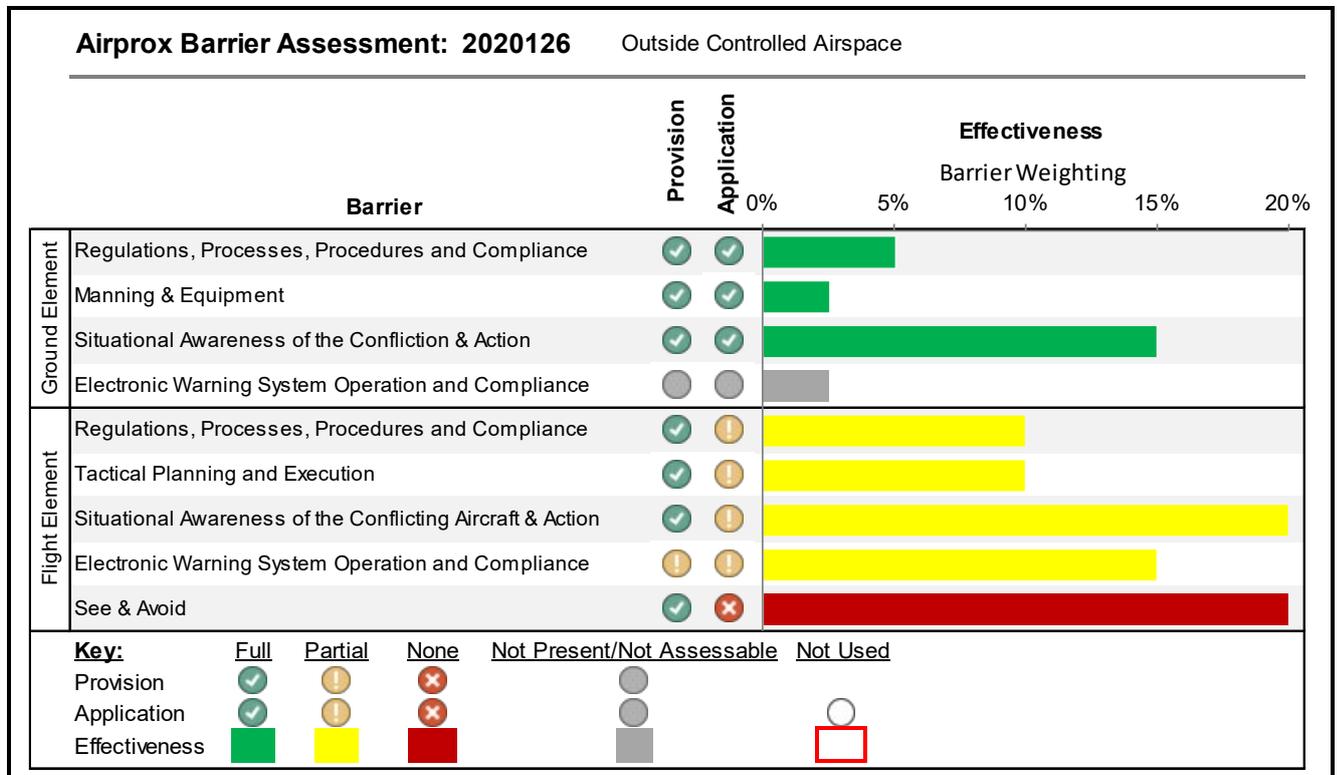
Regulations, Processes, Procedures and Compliance were assessed as **partially effective** because the DA42 pilot's go-around was conducted overhead the runway at a low altitude as the JP commenced its take-off roll.

Tactical Planning and Execution was assessed as **partially effective** because the JP pilot lined-up when take-off could not be commenced immediately and the DA42 pilot did not commence the go-around until at a late stage.

Situational Awareness of the Conflicting Aircraft and Action were assessed as **partially effective** because the available SA was only partially acted upon.

Electronic Warning System Operation and Compliance were assessed as **partially effective** because the DA42 TAS alerted but did not prompt appropriate action.

See and Avoid were assessed as **ineffective** because the JP pilot did not see the DA42 before CPA and the DA42 pilot became unsighted to the JP and did not take effective action to increase separation.
