**AIRPROX REPORT No 2020163**

Date: 12 Nov 2020 Time: 1500Z Position: 5713N 00207W Location: Aberdeen

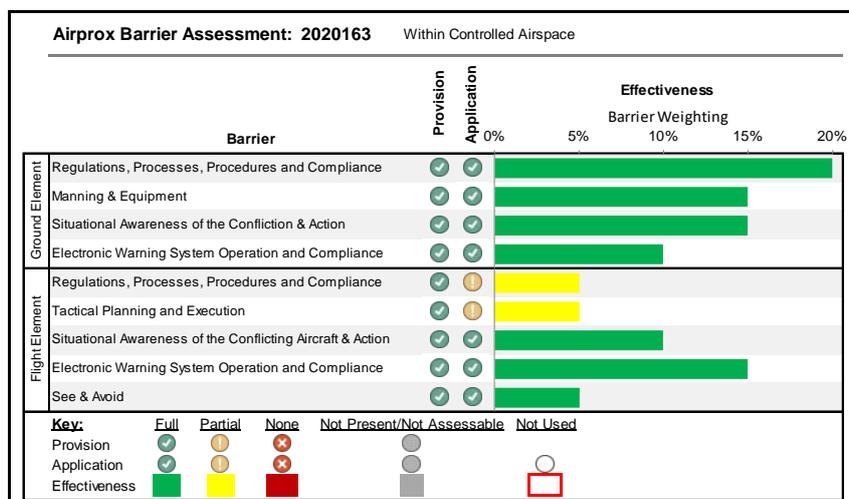
**Regulations, Processes, Procedures and Compliance** were assessed as **partially effective** because the EC175 pilot did not adhere to the ATC order of recovery.

**Tactical Planning and Execution** was assessed as **partially effective** because the EC175 pilot was informed that they were No2 to the S92, but positioned ahead of it.
