## **AIRPROX REPORT No 2019108**

Date: 16 May 2019 Time: 1540Z Position: 5201N 0019W Location: Henlow

An Airprox was reported when a DH82 and a AS355 flew into proximity in the Henlow visual circuit at 1540hrs on Thursday 16<sup>th</sup> May 2019. Both pilots were operating under VFR in VMC, the DH82 pilot in receipt of a AGCS from Henlow and the AS355 pilot was in receipt of a Basic Service from Luton.

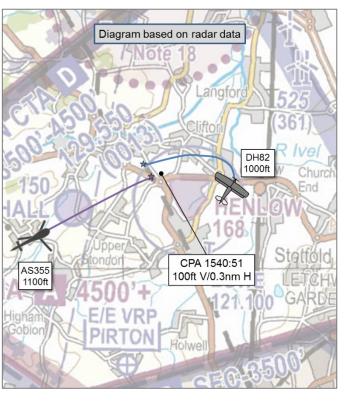
**THE DH82 PILOT** reports that he was downwind to land at Henlow RW08R (but on a left-hand circuit). He was just over halfway down the downwind leg at 1000ft when he saw a black and yellow Squirrel at the same level pass a couple of wing-spans away on their port side, between them and the airfield. He first saw something pass behind the port front cabane strut and recognised it as a helicopter as it passed the rear strut. No avoiding action was taken by either aircraft and no call had been heard by the DH82 pilots or Henlow radio. It was first seen at about 300m and passed abeam by 30m.
