AIRPROX REPORT No 2019180

Date: 07 Jul 2019 Time: 1428Z Position: 5143N 00009E Location: North Weald

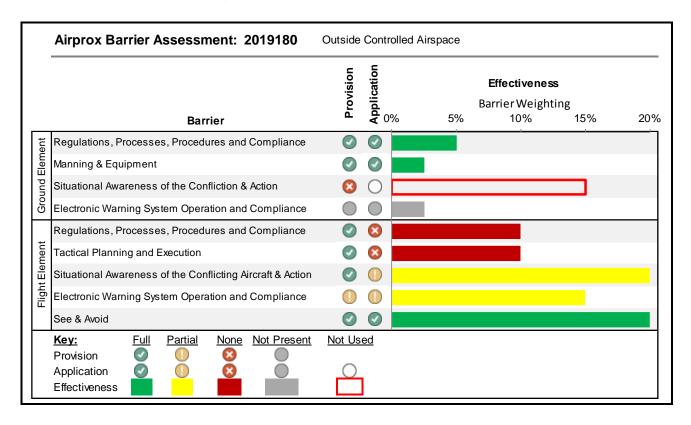
Situational Awareness of the Conflicting Aircraft and Action were assessed as **partially effective** because the EC120 pilot heard the MD902 on the North Weald frequency and so had some awareness of its presence.

Electronic Warning System Operation and Compliance were assessed as **partially effective** because although he received TAS alerts, the MD902 pilot was not able to distinguish the EC120 from other aircraft that were present at the airfield.
