AIRPROX REPORT No 2019274

Date: 14 Sep 2019 Time: 1407Z Position: 5334N 00056W Location: 6NM NE Doncaster Airport

PART A: SUMMARY OF INFORMATION REPORTED TO UKAB

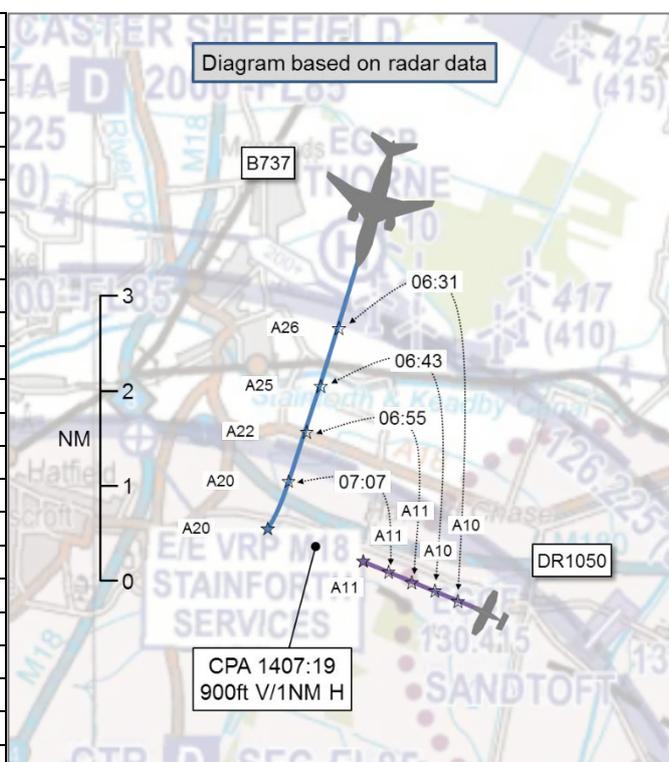
Recorded	Aircraft 1	Aircraft 2
Aircraft	B737	DR1050
Operator	CAT	Civ FW
Airspace	Doncaster CTR	Doncaster CTR
Class	D	D
Rules	IFR	VFR
Service	Radar Control	None
Provider	Doncaster App	N/A
Altitude/FL	2000ft	1100ft
Transponder	A, C, S	A, C, S
Reported		
Colours	Company	Blue, white
Lighting	All on except logo	Strobes, nav
Conditions	VMC	VMC
Visibility	'CAVOK'	10NM
Altitude/FL	2400ft	1000ft
Altimeter	QNH (1030hPa)	QNH (1031hPa)
Heading	205°	315°
Speed	180kt	70kt
ACAS/TAS	TCAS II	Not fitted
Alert	TA	N/A
Separation		
Reported	NK	Not seen
Recorded	900ft V/1NM H

THE DONCASTER APPROACH CONTROLLER reports [B737 C/S] was established on 6.5nm final ILS approach to RW20 when it became necessary to issue an avoiding action turn and climb to the west, due to unknown traffic crossing the [Sandtoft] western ATZ boundary into CAS without any communication with, nor clearance from, ATC. [B737 C/S] was vectored into the north-western CTA to achieve lateral separation with regard to the unknown traffic, before being vectored back onto the ILS once the unknown aircraft was sufficiently clear of the RW20 final approach. No RTF contact was received from the infringing aircraft at any stage, either whilst it transited Doncaster CAS, nor subsequently. The minimum separation was 1000ft vertically and 0.5nm horizontally.
