AIRPROX REPORT No 2018008

Date: 16 Jan 2018 Time: 1227Z Position: 5128N 00025W Location: Heathrow airport

PART A: SUMMARY OF INFORMATION REPORTED TO UKAB

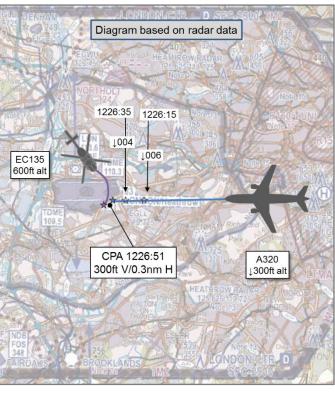
T	Maria de la companya del companya de la companya del companya de la companya de l	calculate data to
Recorded	Aircraft 1	Aircraft 2	GLD DENHAM	
Aircraft	A320	EC135	249	Diag
Operator	CAT	NPAS		GWIII
Airspace	London CTR	London CTR	12	6.450
Class	D	D	WAY TO MAKE	TO DE LA COLO
Rules	IFR	VFR		C124
Service	Aerodrome	Aerodrome	Note 13	1226
Provider	Heathrow	Heathrow		IONU
Altitude/FL	300ft	600ft		3.6
Transponder	A,C,S	A,C,S	EC135 600ft alt	10 110
Reported				
Colours	Company	Blue/yellow		1
Lighting	Strobes, landing,	Strobes, HISL,	TDME 109.5	
	nav	nav, 2xlanding	STAVES	
Conditions	VMC	VMC		CF
Visibility	10km	10km		3001
Altitude/FL	300ft	700ft		100
Altimeter	QNH (997hPa)	Rad Alt		
Heading	270°	180°		124
Speed	130kt	120kt	F NDB	
ACAS/TAS	TCAS II	TCAS I	P NOB 25 FOS 348	256
Alert	TA	TA	FAIROAKS -	BROOK
Separation				
Reported	200ft V/1200m H	500ft V/1.5nm H		
Recorded	300ft V/0.3nm H
