AIRPROX REPORT No 2018026

Date: 25 Jan 2018 Time: 1122Z Position: 5216N 00053E Location: Mildenhall

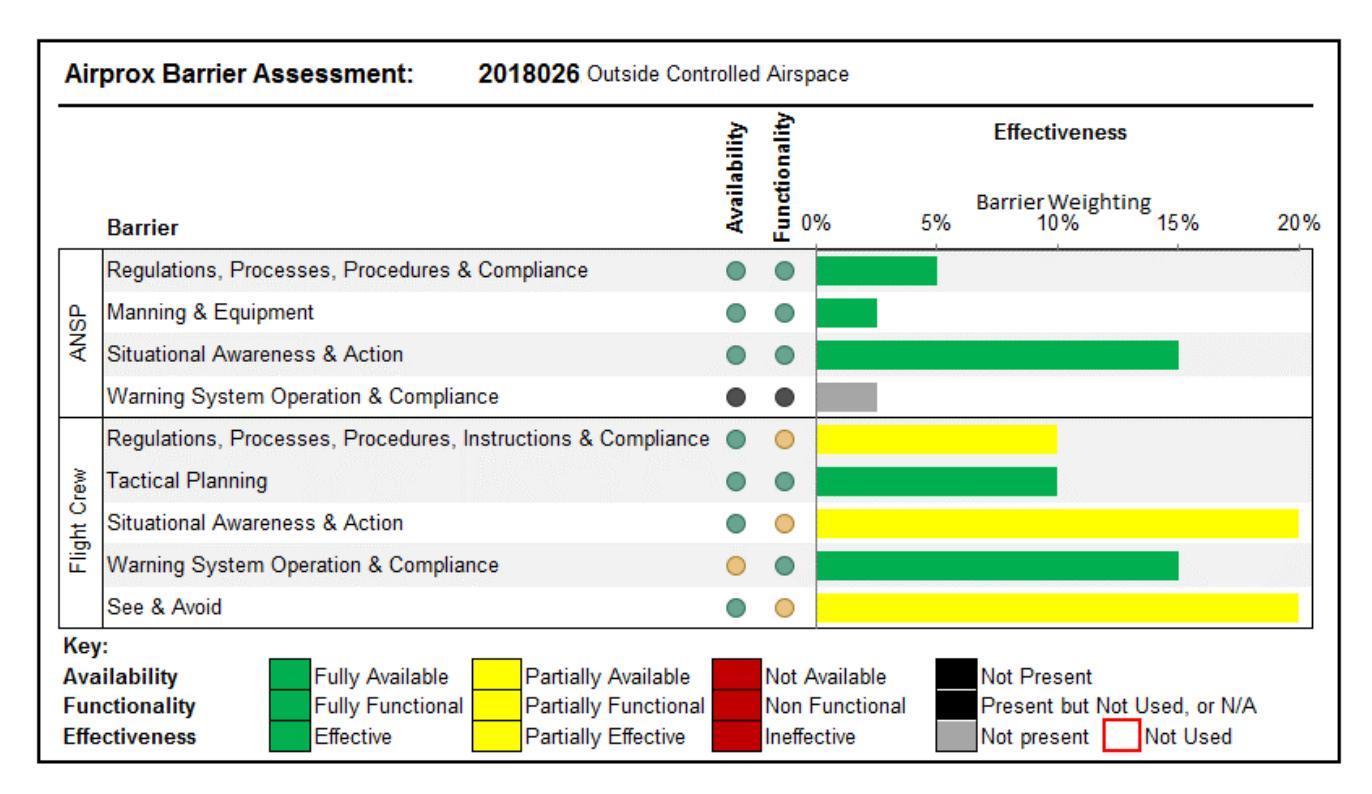
Safety Barrier Assessment³

In assessing the effectiveness of the safety barriers associated with this incident, the Board concluded that the key factors had been that:

Flight Crew:

Regulations, Processes, Procedures, Instructions and Compliance were assessed as **partially effective** because the C21 pilot did not give way to the RV6 who was converging from the right.

Situational Awareness and Action were assessed as **partially effective** because although the C21 pilot had been given Traffic information, he didn't take positive early action to resolve the situation.

See and Avoid were assessed as **partially effective** due to the late avoiding action taken by the C21, and the non-sighting by the RV6 pilot.
