AIRPROX REPORT No 2018027

Date: 23 Feb 2018 Time: 1227Z Position: 5126N 00106W Location: 6nm SE CPT

PART A: SUMMARY OF INFORMATION REPORTED TO UKAB

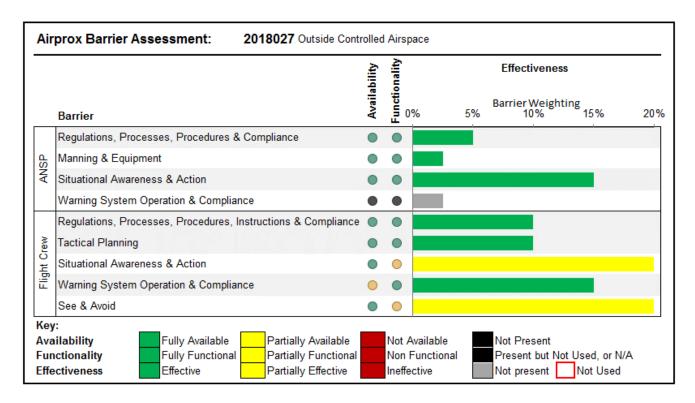
Situational Awareness and Action were assessed as **partially effective** because neither pilot effectively used the available SA to avoid each other.

See and Avoid were assessed as **partially effective** because although each pilot was visual with the other aircraft, the closer than desirable separation between them was enough to cause concern to the Puma crew.
