AIRPROX REPORT No 2018060

Date: 22 Apr 2018 Time: 1314Z Position: 5108N 00214W Location: Park Gliding Site

PART A: SUMMARY OF INFORMATION REPORTED TO UKAB

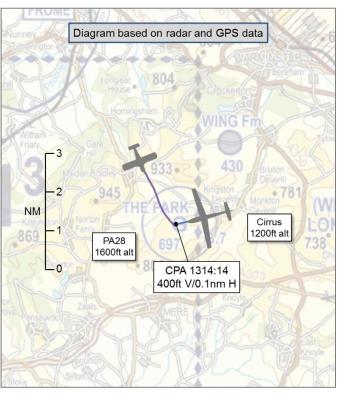
Dagandad	Ainamatt 4	Ainauati O
Recorded	Aircraft 1	Aircraft 2
Aircraft	Cirrus glider	PA28
Operator	Civ Club	Civ Club
Airspace	London FIR	London FIR
Class	G	G
Rules	VFR	VFR
Service	None	AGCS
Provider	N/A	Compton Abbas
Altitude/FL	1200ft	1600ft
Transponder	Not fitted	A, C, S
Reported		
Colours	White, orange	White, blue
Lighting	Not fitted	Nav, landing
Conditions	VMC	VMC
Visibility	>10km	5-8km
Altitude/FL	500ft	2000ft
Altimeter	agl	QNH (1010hPa)
Heading	260°	150°
Speed	60kt	95kt
ACAS/TAS	FLARM	Not fitted
Alert	None	N/A
Separation		
Reported	600ft V/500ft H	900ft V/900m H
Recorded	400ft V/~0.1nm H
