AIRPROX REPORT No 2018108

Date: 11 May 2018 Time: 1456Z Position: 5352N 00137W Location: Leeds/Bradford airport

PART A: SUMMARY OF INFORMATION REPORTED TO UKAB

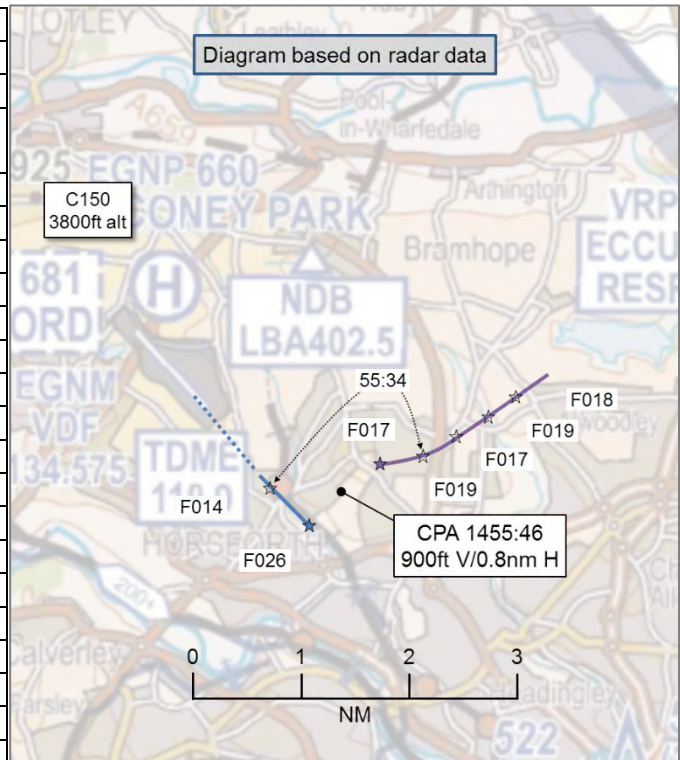
THE LEEDS/BRADFORD AERODROME CONTROLLER reports that a solo student in the PA28 was joining the circuit downwind left-hand for RW14 from ECCUP Visual Reference Point (VRP). He was given the QFE and told to report downwind left-hand. The B737 became airborne at 1455 from RW14. As the B737 passed 2nm on the climb-out, the PA28 was observed from the Visual Control Room approximately 0.5-1nm east of the B737, tracking west. The PA28 pilot was instructed to turn north to remain clear of the climb-out and was asked to confirm he was positioning for downwind. The pilot reported that he would turn downwind in 2 minutes which put him downwind right-hand. The PA28 continued west instead of turning so the pilot was then instructed to continue for downwind right-hand because turning north for downwind left-hand would have exposed the PA28 to more wake turbulence from the departing traffic and would have turned it over the runway when an inbound aircraft was at 3nm to land. The B737 pilot reported a TA and then continued enroute after it was explained that the light aircraft had flown through the climb-out lane behind him. Once the PA28 was west of the airport the pilot was instructed to turn downwind. The controller made the decision to only give the pilot one command at a time to give himself greater control of him. A helicopter was holding on the southwest airport boundary waiting to transit; the helicopter was visible at all times. No comments were made about the Airprox to the student on the frequency because he was on his own and the controller did not think it sensible to comment at the time.

THE BOEING 737 PILOT reports that after take-off from RW14 the pilot of a light aircraft, who was meant to turn downwind for RW14, drifted towards the runway centreline. ATA was received at about 400ft. They were visual with the aircraft and decided no action was required.

Cause: The PA28 student pilot routed to join downwind right-hand by mistake and flew into proximity with the B737.
