AIRPROX REPORT No 2018232

Date: 23 Aug 2018 Time: 1333Z Position: 5112N 00139W Location: 5nm NE Boscombe Down

PART A: SUMMARY OF INFORMATION REPORTED TO UKAB

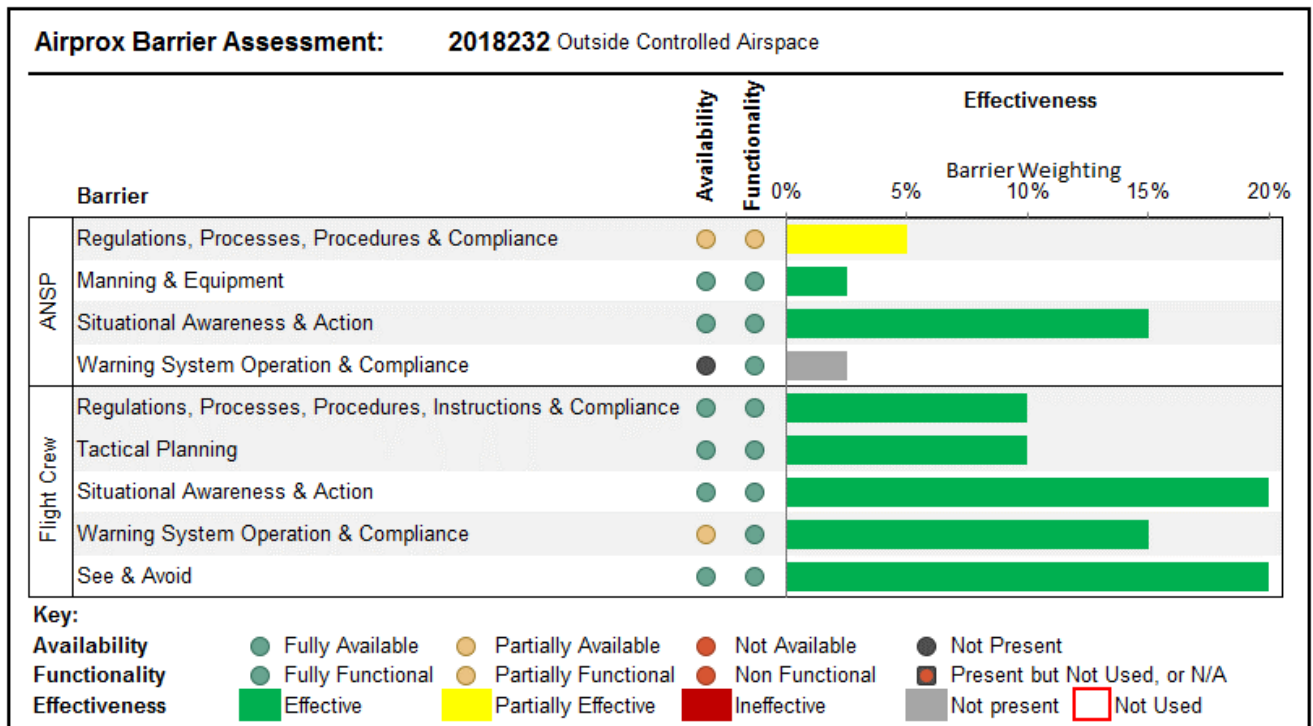
Flight Crew:

Warning System Operation and Compliance were assessed as **partially available** because only the C130 was believed to have been equipped with an electronic warning system.
