**AIRPROX REPORT No 2018286**

Date: 23 Oct 2018 Time: 1557Z Position: 5129N 00009W Location: 12nm E Heathrow

**PART A: SUMMARY OF INFORMATION REPORTED TO UKAB**

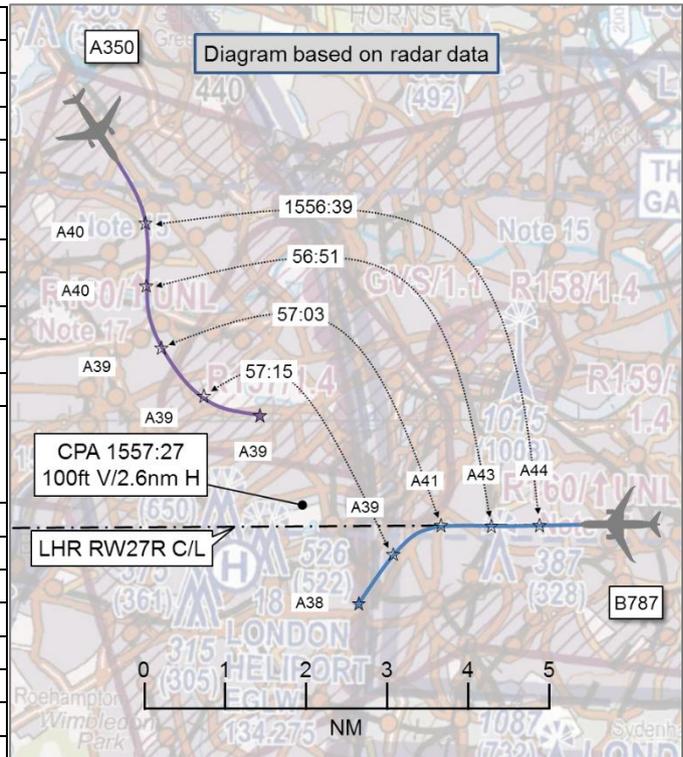
**THE BOEING 787 PILOT** reports that they were established on the ILS RW27R at Heathrow. It became apparent that an Airbus A350 was on a southerly heading towards the Localiser and into conflict with them. The A350 pilot was not responding to instructions so avoiding action was given to the B787 by the controller consisting of an immediate turn to the south. The A350 turned eastwards shortly afterwards and passed to the right of them in the opposite direction.

on top of him, she turned the A350 pilot right onto 095° and reduced his speed to 180kt. The B787 was just establishing onto RWY27R at about 14nm when she noticed that the A350's heading did not look right. She informed the pilot that the heading should have been heading 095° and to turn left onto 080°. She did not think that she received a readback and then the pilot said they were turning onto 095°. She replied negative, turn left immediately onto 360°, but again she did not think that she received a readback. Her only option then was to break the B787 off its approach as the A350 was heading straight towards it. She gave the B787 pilot avoiding action and turned him left onto south. She returned to the A350 pilot and gave him avoiding action onto north. She then gave Traffic Information to the B787 pilot and he reported that he had the traffic in sight.
