AIRPROX REPORT No 2017064

Date: 12 Apr 2017 Time: 1732Z Position: 5123N 00028W Location: Heli-route 3

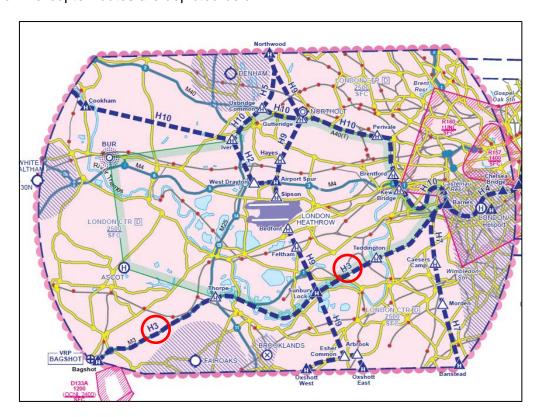
Figure 1 London Heli-Routes (H3 ringed)

Pilots should fly the precise routes as depicted on the 1: 50 000 Map entitled Helicopter Routes in the London Control Zone. 'Corner cutting' is to be avoided. In order to obtain sufficient lateral separation from opposite direction traffic, pilots may temporarily deviate to the right of the route².
