AIRPROX REPORT No 2017179

Date: 29 Jul 2017 Time: 1008Z Position: 5207N 00005E Location: 6nm SW Cambridge Airport

PART A: SUMMARY OF INFORMATION REPORTED TO UKAB

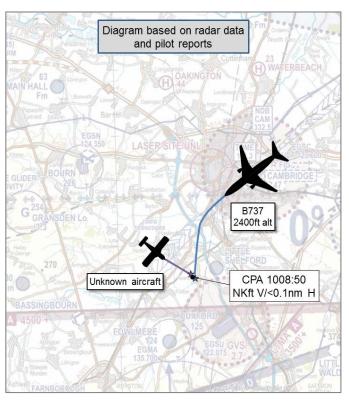
THE B737 PILOT reports that he was being handed over from Cambridge to Stansted Director in level flight at altitude 2500ft after initial departure from Cambridge. An aircraft was seen in his 2 o'clock position, at the same level. The aircraft immediately banked to the right (approx 45° AOB) at the same time that he turned his aircraft left to avoid. His turn was discontinued after approximately 15 degrees because the other aircraft had turned and was tracking away by then. Stansted Director informed him of a primary radar contact at the same time he was turning to avoid.

He assessed the risk of collision as 'High'.
