**AIRPROX REPORT No 2017181**

Date: 29 Jul 2017 Time: 1111Z Position: 5049N 00016W Location: 1nm SE Brighton City Airport

**PART A: SUMMARY OF INFORMATION REPORTED TO UKAB**

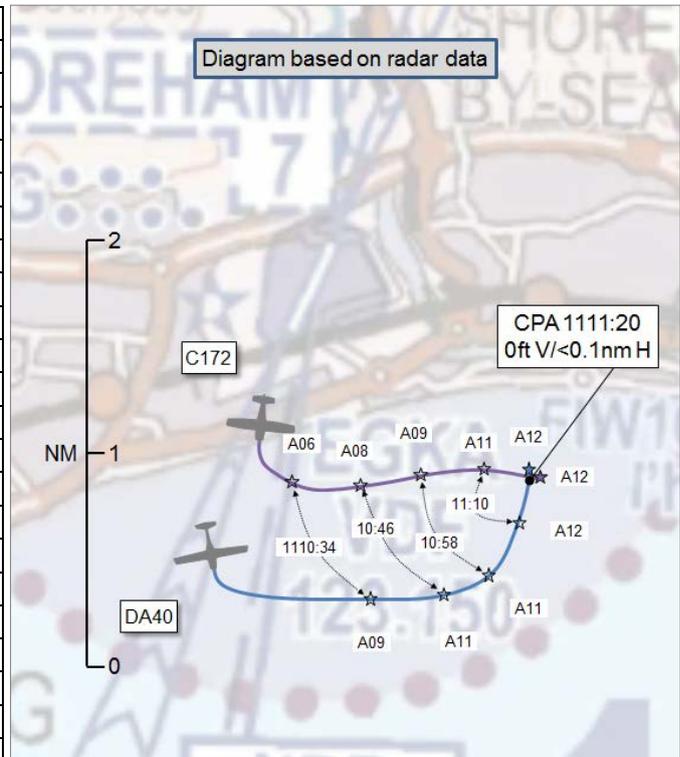
**THE DIAMOND DA40 STAR PILOT** reports that after conducting a touch-and-go, the C172 pilot was cleared to take-off behind them. They flew a normal circuit pattern climbing to 600ft upwind and turning crosswind approximately 1nm south of the coast. He observed the C172 after its take-off crossing the railway line. They levelled at 1100ft and turned onto the downwind leg where he could no longer see the C172 upwind. At a range of approximately 100-150m he spotted the C172 to their left in their approximate 10 o'clock position climbing towards them, tracking parallel to the coast. His student initiated a climb as the C172 passed underneath them by 50-100ft. The C172 pilot proceeded to climb (afterwards reporting climbing to 1600ft) and tracked towards the centre of Brighton.

**THE CESSNA 172 SKYHAWK PILOT** reports that, after being cleared for take-off, he climbed at full power and 85mph IAS maintaining RW20 heading until passing the coastline at 600ft. Shortly afterwards, having the aircraft on a nose-high attitude he looked out accurately before turning onto heading 070° in order to clear the ATZ as soon as possible. He did not see any other traffic approaching his flight-path. By the time the Aerodrome controller asked the DA40 pilot if he was visual with the traffic taking off he rolled out, wings level, and saw the DA40 at the same altitude slightly nose-down at 1000ft towards the right-hand side of his aircraft. Being still slow and in a climb, he decided to pitch down in order to separate himself from the incoming aircraft that apparently did not seem to perform any avoiding action. On frequency, the DA40 instructor, at the last moment when he pitched down, responded 'visual' to the Tower.

Cause: The C172 pilot climbed into conflict with the DA40 downwind.
