AIRPROX REPORT No 2017235

Date: 28 Sep 2017 Time: 1528Z Position: 5143N 00043W Location: Bovingdon VOR

PART A: SUMMARY OF INFORMATION REPORTED TO UKAB

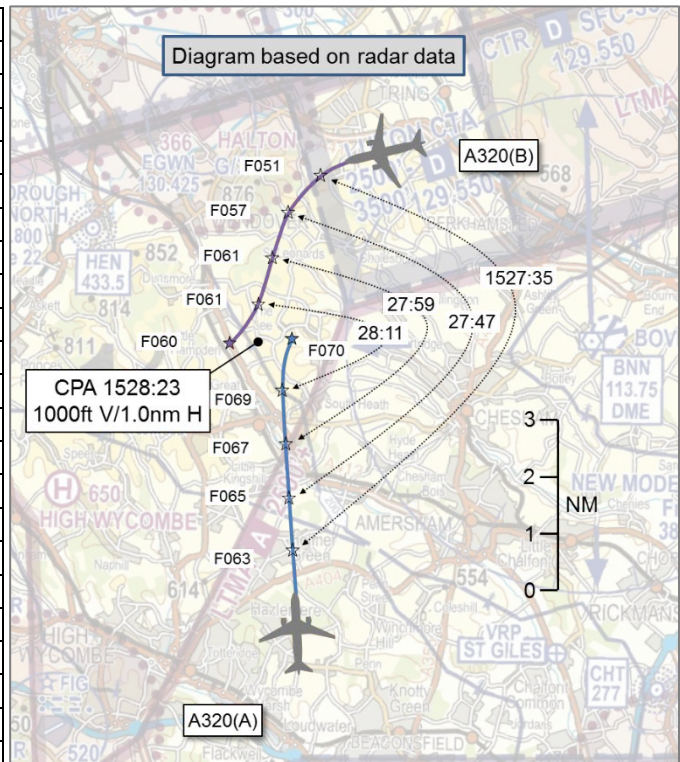
Recorded	Aircraft 1	Aircraft 2
Aircraft	A320(A)	A320(B)
Operator	CAT	CAT
Airspace	London TMA	London TMA
Class	A	A
Rules	IFR	IFR
Service	Radar Control	Radar Control
Provider	London TC NW	London TC NW
Altitude/FL	FL70	6100ft
Transponder	A,C,S	A,C,S
Reported		
Colours	Company	NK
Lighting	Strobes, landing	NK
Conditions	VMC	NK
Visibility	10km	NK
Altitude/FL	FL70	6000ft
Altimeter	1013hPa	QNH
Heading	010°	NK
Speed	NK	NK
ACAS/TAS	TCAS II	TCAS II
Alert	TA	Unknown
Separation		
Reported	Not seen	NK
Recorded	700ft V/3nm H separation lost 1000ft V/1.1nm H separation gained 1000ft V/1nm H CPA

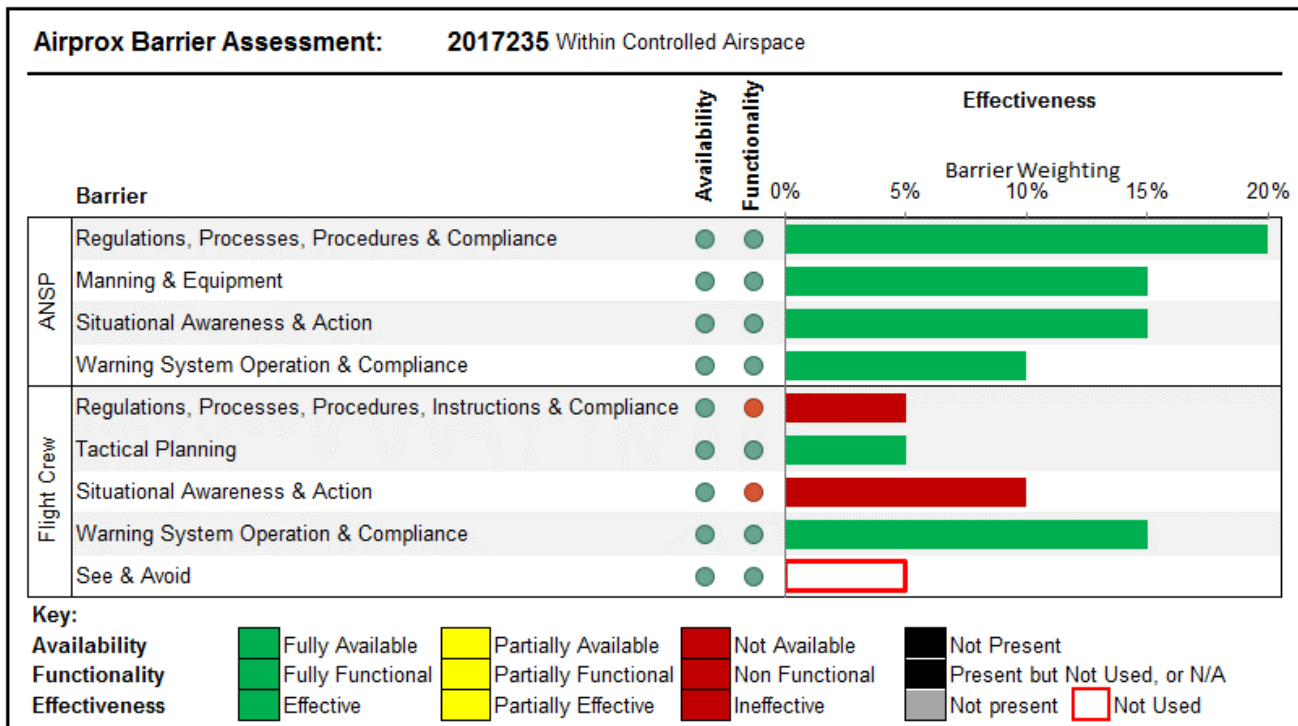
Situational Awareness and Action were assessed as **ineffective** because the A320(B) pilot heard an R/T call made by another pilot, thought that it was an instruction from ATC to him, and climbed without a clearance.

See and Avoid was assessed as **not used** because the two aircraft did not come into such proximity that this barrier was employed.
