**AIRPROX REPORT No 2017247**

Date: 12 Oct 2017 Time: 0935Z Position: 5026N 00032E Location: ivo XIDIL

**PART A: SUMMARY OF INFORMATION REPORTED TO UKAB**

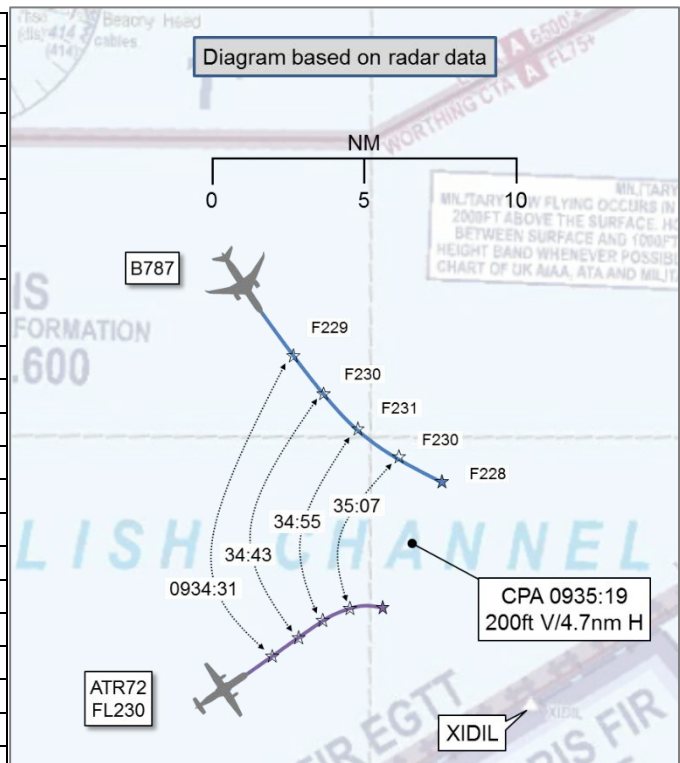
Recorded	Aircraft 1	Aircraft 2
Aircraft	B787	ATR72
Operator	CAT	CAT
Airspace	Airway M605	Airway M605
Class	A	A
Rules	IFR	IFR
Service	Radar Control	Radar Control
Provider	London AC	London AC
Altitude/FL	227	230
Transponder	A,C,S	A,C,S
Reported		
Colours	Company	Company
Lighting	NK	Strobes, nav
Conditions	VMC	VMC
Visibility	NK	>10km
Altitude/FL	FL230	FL230
Heading	NK	030°
Speed	300kt	285kt
ACAS/TAS	TCAS II	TCAS II
Alert	None	None
Separation		
Reported	<1000ft V/NK H	500ft V/5nm H
Recorded	300ft V 4.5nm H

B787 was maintaining FL220 (requesting FL250) heading southerly towards XIDIL. The T controller climbed the B787 pilot to FL250 and then on immediately noticing the conflict, in the next transmission instructed the pilot to maintain FL220. The aircraft by this point was showing FL221 and the B787 pilot did not read back the instruction immediately. The T controller repeated the instruction to descend and maintain FL220 and also turned the aircraft left heading 125° (possibly in the same transmission), the Mode C on the B787 went up to FL230. At this point, avoiding action was given to both aircraft numerous times and she believed separation showed around 4nm on the Separation Monitor.
