## AIRPROX REPORT No 2017276

Date: 16 Dec 2017 Time: 1144Z Position: 5207N 00024E Location: Wrating Common

### PART A: SUMMARY OF INFORMATION REPORTED TO UKAB

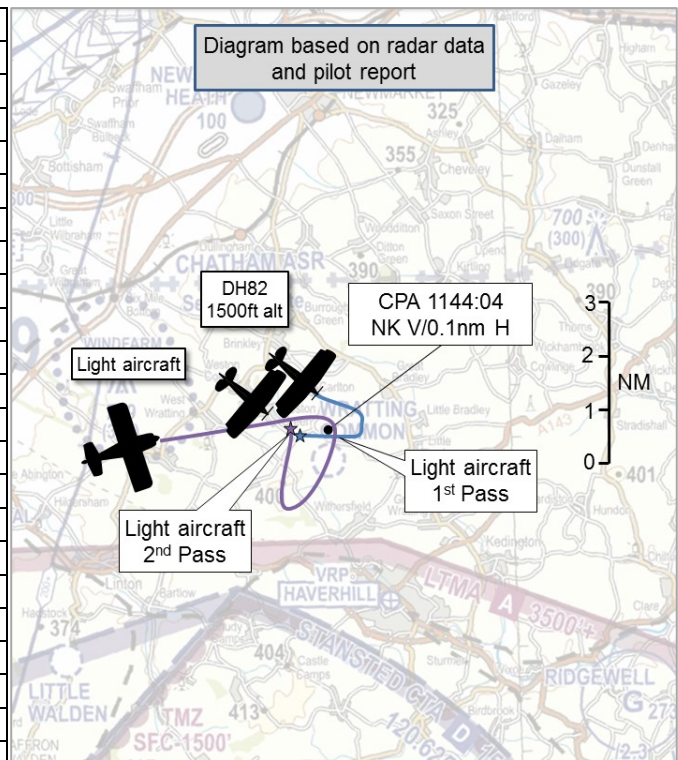
Recorded	Aircraft 1	Aircraft 2
Aircraft	DH82 x 2	Light-aircraft
Operator	Civ Club	Unknown
Airspace	London FIR	London FIR
Class	G	G
Rules	VFR	NK
Service	Basic	
Provider	Cambridge	
Altitude/FL	1500ft	NK
Transponder	A, C, S	State/Modes
<b>Reported</b>		
Colours	Yellow, Silver	Blue
Lighting	None	NK
Conditions	VMC	
Visibility	>10km	
Altitude/FL	1500ft	
Altimeter	QNH (1017hPa)	
Heading	300°	
Speed	70kt	
ACAS/TAS	Not fitted	
<b>Separation</b>		
Reported	0ft V/30m H	NK
Recorded	NK V/0.1nm H

**THE DH82 PILOT** reports that he was conducting a formation training flight with a second DH82. Both aircraft departed Cambridge in formation towards a windfarm 5nm SE of Cambridge and then on to the disused Wrating Common airfield. The aircraft had turned to return to Cambridge at which time he was formatting on the other DH82, echelon right. The other aircraft, he thought possibly a Vans RV6 or RV9, came from behind the formation and joined echelon left for several minutes. He spotted the other aircraft approximately 100ft to the left and rear of the formation and attempted to wave it away while easing out to give the other DH82 room to manoeuvre. They did not receive any TI from Cambridge regarding the other aircraft he thought. The other aircraft then dived and broke away going unsighted under the formation. The DH82 formation had just changed leader to the other DH82, so both pilots were busy re-establishing close formation and setting up to re-join Cambridge circuit for a formation landing. A verbal report was given by telephone after landing to Cambridge ATC.

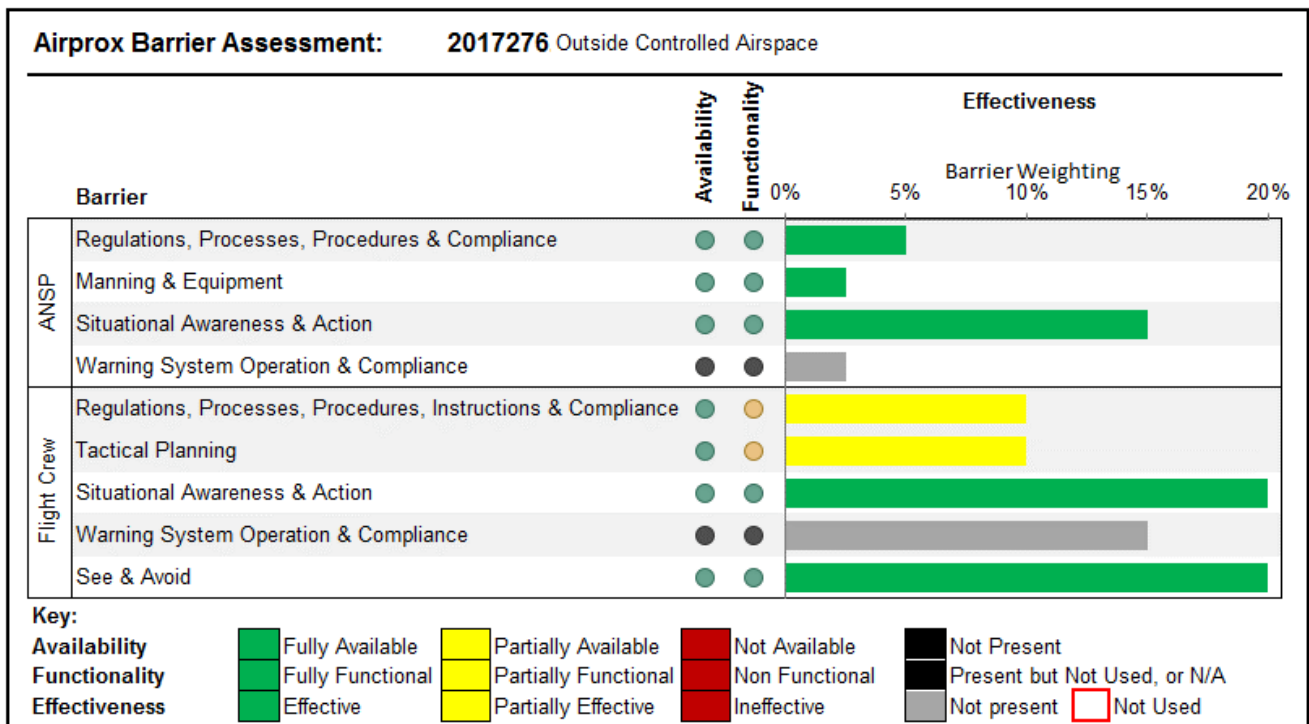
**Regulations, Processes, Procedures, Instructions and Compliance** were assessed as **partially effective** because the unknown light-aircraft pilot had flown close enough to the DH82 formation to give the DH82 pilots the impression that he was trying to formate on the formation.

**Tactical Planning** was assessed as **partially effective** because the DH82 formation were operating under a Basic Service; although they did receive Traffic Information in this instance, they would have been better advised to have requested a Traffic Service.
