### AIRPROX REPORT No 2016241

Date: 13 Nov 2016 Time: 1258Z Position: 5116N 00253W Location: ivo Cheddar Reservoir VRP

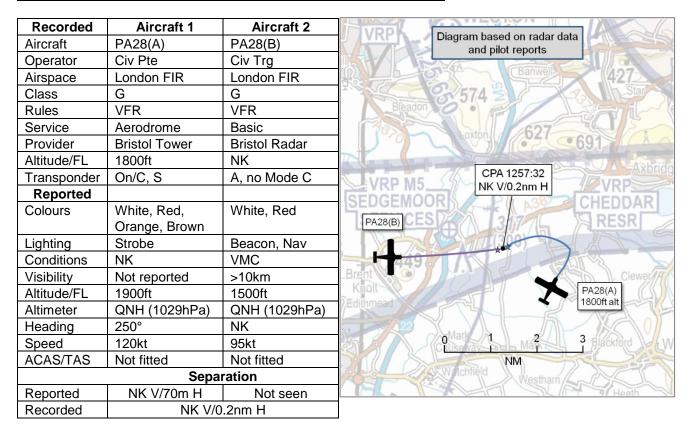
**THE PA28(A) PILOT** reports that she was returning to Bristol and was told by Bristol Radar to report 3nm to the [Cheddar Reservoir] VRP. Upon reporting she was transferred to Bristol Tower who instructed her to hold outside the zone; she was approximately half a mile from the VRP by this time. She commenced a left-hand orbit and after turning through 120°, saw very close opposite direction traffic. She took immediate avoiding action, a steep turn to the right. As she passed within around 70m of the opposing aircraft it also turned right. She then informed ATC of the occurrence and her position, and then received joining instructions. She considers one contributory factor may be holding outside controlled airspace having already been transferred to the tower frequency; assuming that the other aircraft was on radar/LARS, when holding outside controlled airspace but talking to the tower you do not have the situational awareness provided by listening to other aircraft. She has often thought that it would be much safer to be held just inside the zone, providing separation etc. permits.

She assessed the risk of collision as 'High'.
