AIRPROX REPORT No 2016273

Date: 29 Nov 2016 Time: 1453Z Position: 5057N 00216W Location: 4.2nm WSW Compton Abbas

PART A: SUMMARY OF INFORMATION REPORTED TO UKAB

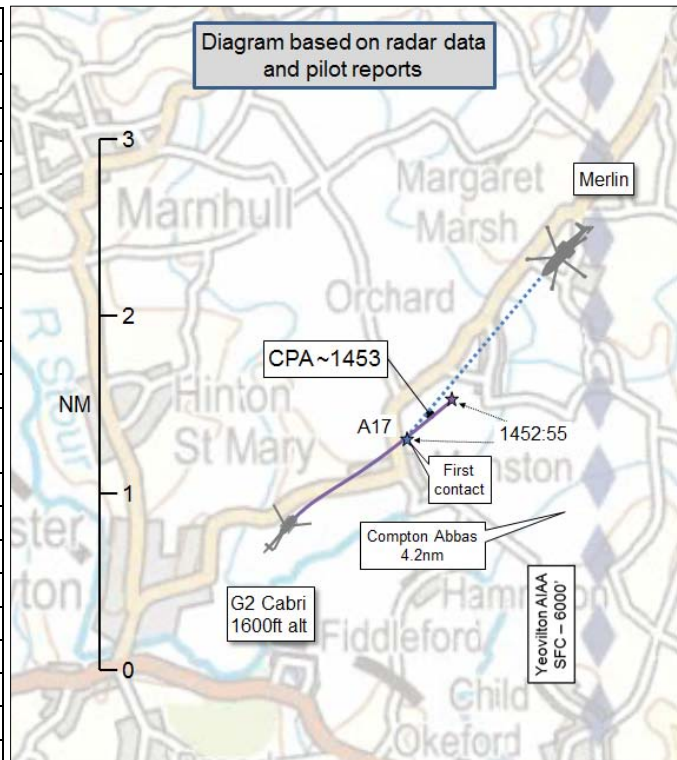
THE MERLIN PILOT reports conducting an IRT. During the descent into low-level the radar service was downgraded from a Traffic Service to a Basic Service as the aircraft descended below radar cover. No mention had been made by ATC or any crew member of any traffic in the vicinity. After no more than 2 minutes at low-level a simulated unexpected entry into cloud was initiated by the non-handling pilot instructor. The handling pilot, in accordance with standard procedures, immediately began flying the aircraft with sole reference to the instruments and initiated an emergency climb, with maximum continuous power whilst reducing speed to 80kts. At approximately 1500ft the non-handling pilot made a vocal exclamation as he saw a blue and white civilian helicopter at a similar level in the 12 o'clock position at no more than 100 yards distance. The flight path of the other aircraft was right to left, having approached from the 1-2 o'clock (southwest), and passed directly ahead. The aircraft was not seen until it was diverging and would likely have been in the non-handling (LHS) pilot's blind spot, i.e. behind the overhead console. The pilot noted that it was likely their aircraft would also have been in a blind spot of the civilian aircraft as they were climbing at a steep angle from his low left. It was the belief of both Merlin pilots that the civilian aircraft pilot was at no time aware of their presence and was not seen to have taken, or subsequently take, any avoidance manoeuvres. The weather was extremely clear but with a very low and bright sun, towards which the Merlin was heading, a factor that had been mentioned by the handling pilot whilst at low-level and which had forced a decision to 'keep the height up' at low-level for safety due to the reduced into-sun visibility. The civilian aircraft would have approached from the sun making it harder to see. After the event, ATC were questioned as to whether they had anything on radar and the crew were informed they were holding one contact that matched the position of the civilian aircraft, but had no height information. It was the belief of both Merlin pilots that had their aircraft been 100 yards further ahead a collision would likely have resulted. The Merlin pilot noted that they had made an error by not reporting the Airprox by radio.

In the event, the Board agreed that the Airprox had been caused by a late sighting of the Cabri by the Merlin crew and a non-sighting of the Merlin by the Cabri pilots. Members also agreed that the geometry of the conflict was such that the Merlin pilot had only seen the Cabri as it entered his field of view, that he would have had little time to change the situation, and so providence had played a major part in determining the aircrafts' separation at CPA.

Cause: A late sighting by the Merlin crew and a non-sighting by the Cabri pilot.

1. Instructors have been reminded that when conducting IRTs they are to inform ATC of their intention to conduct instrument PFLs followed by Low-Level IF Abort and to request an update on any other air traffic in the vicinity.
2. Instructors have been reminded to ensure clearing turns (away from sun) are conducted prior to completing simulated Low Level IF Aborts, during which lookout will, by necessity, be degraded.
3. All squadron aircrew have been re-briefed on the importance of reporting a perceived Airprox in a timely manner.
