### **AIRPROX REPORT No 2016159**

Date: 03 Aug 2016 Time: 0945Z Position: 5430N 00222W Location: NW Kirkby Stephen

# PART A: SUMMARY OF INFORMATION REPORTED TO UKAB

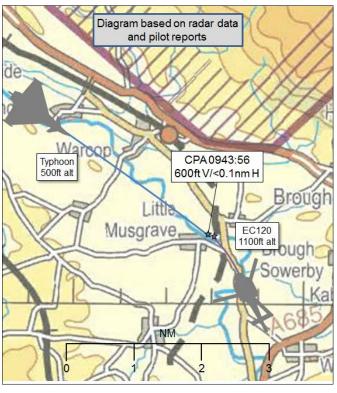
Recorded	Aircraft 1	Aircraft 2			
Aircraft	Typhoon	EC120			
Operator	HQ Air (Ops)	Civ Pte			
Airspace	London FIR	London FIR			
Class	G	G			
Rules	VFR	VFR			
Service	None	Basic			
Provider	LL Common	London			
		Information			
Altitude/FL	500ft agl	1100ft agl			
Transponder	С	С			
Reported					
Colours	Grey	Silver, Green			
Lighting	Nav, Anti Col	Nav, Anti Col,			
		Landing			
Conditions	VMC	NK			
Visibility	10km	NK			
Altitude/FL	400ft	1500ft			
Altimeter	NK (1013hPa)	QNH (997hPa)			
Heading	100°	330°			
Speed	420kt	120kt			
ACAS/TAS	Not fitted	Not fitted			
Alert	N/A N/A				
	Separation				
Reported	orted 500ft V/1000ft H Not Seen				
Recorded	600ft V/<0.1nm H
