**AIRPROX REPORT No 2016166**

Date: 20 Jul 2016 Time: 1400Z Position: 5242N 00047E Location: NE Marham

**PART A: SUMMARY OF INFORMATION REPORTED TO UKAB**

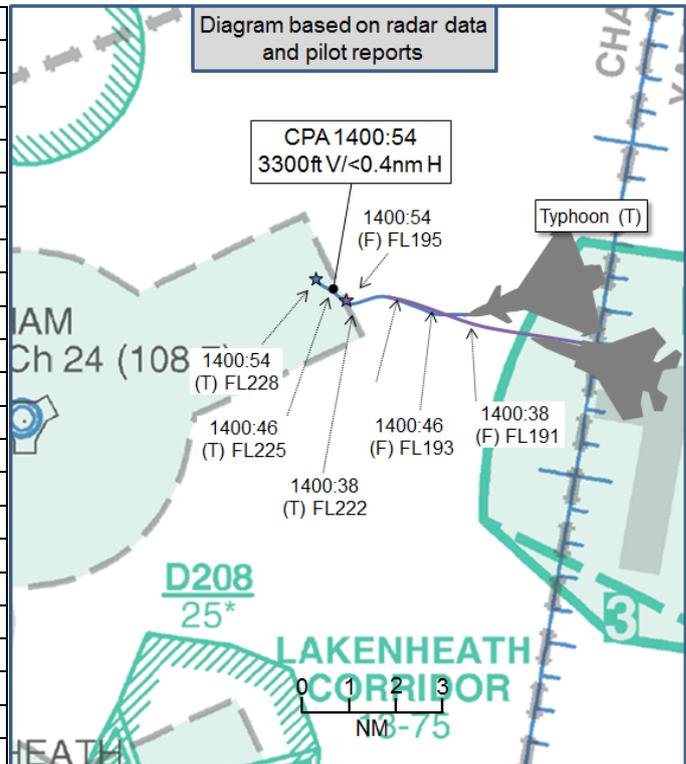
Recorded	Aircraft 1	Aircraft 2
Aircraft	Typhoon	F15
Operator	HQ Air (Ops)	Foreign Mil
Airspace	London FIR	London FIR
Class	C	C
Rules	VFR	VFR
Service	Traffic	Traffic
Provider	Swanwick Mil	Swanwick Mil
Altitude/FL	FL228	FL195
Transponder	C on, S off	C, S
Reported		
Colours	NK	Grey
Lighting	NK	Standard
Conditions	VMC	VMC
Visibility	10km	>10km
Altitude/FL	20,000ft	FL190
Altimeter	RPS (1000hPa)	QNH (1013hPa)
Heading	270°	270°
Speed	300kt	330kt
ACAS/TAS	Not fitted	Not fitted
Alert	N/A	N/A
Separation		
Reported	700ft V/NK H	1000ft V/NK H
Recorded	3300ft V/0.4nm H & 700ft V/2nm H
