AIRPROX REPORT No 2016187

Date: 23 Aug 2016 Time: 1057Z Position: 5624N 00316W Location: 5nm W Dundee airport

PART A: SUMMARY OF INFORMATION REPORTED TO UKAB

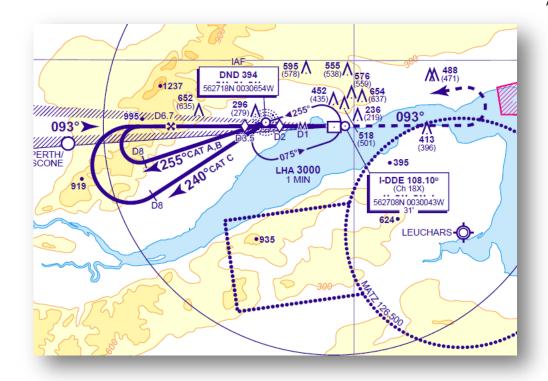
At 1051:06, the controller advised the DHC8 pilot that the glidepath was on maintenance and that either a Localiser-only approach was available or the glidepath could be returned to use in approximately 4 minutes. Following a slight pause, the DHC8 pilot chose to make a LOC/DME approach (Figure 1).

Figure 1 LOC/DME chart for RW09 at Dundee.

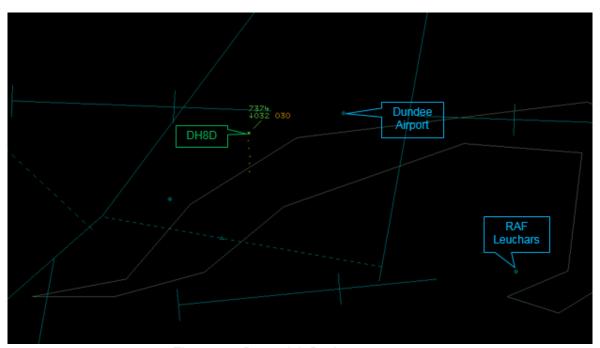
At 1051:38 (Figure 2), the controller instructed the DHC8 pilot to report beacon outbound on the approach.

Figure 2 – Prestwick Radar at 1051:38.
