AIRPROX REPORT No 2016216

Date: 23 Sep 2016 Time: 1031Z Position: 5243N 00021W Location: 7nm NE RAF Wittering

PART A: SUMMARY OF INFORMATION REPORTED TO UKAB

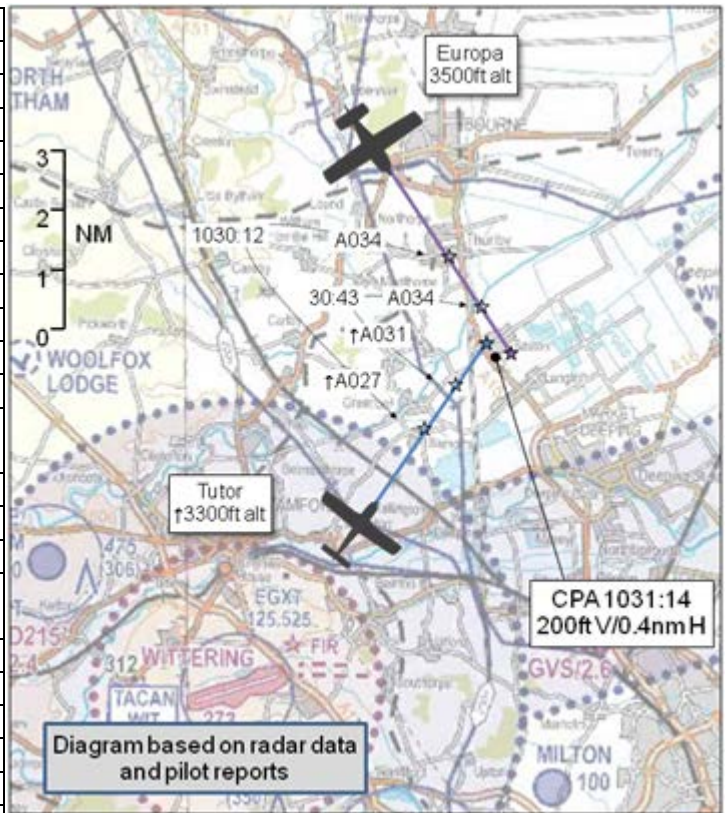
THE TUTOR T1 PILOT reports that he was at approximately 4700ft and about 7nm NE Wittering in the vicinity of Langtoft village, heading NE, when ATC called pop-up traffic 1nm NE, at a similar level. The traffic was not sighted. After his initial visual scan, the traffic was still not sighted, so he manoeuvred to provide a better view and to displace vertically in order to deconflict. He obtained a late sighting of traffic approximately 100ft above, 200 yards laterally. There was a late return on TAS appearing at approximately 1nm. The traffic appeared to be low-wing, single-engine propeller, red and white, possibly a Robin. It was routing south-east, level. Its pilot did not respond to his wing-rock so he presumed that he had not seen them. The sortie continued uneventfully.

and avoid' each other despite the assistance of ATC. The Tutor pilot reported that he had received a TAS alert when the two aircraft were 1nm apart, had seen the Europa approximately 100ft above at a range of 200yd, and had carried out a wing-rock but with no response from the Europa pilot. Although the Europa pilot could not recollect the specific details of his flight, he did report that neither him, nor his passenger, could remember seeing any aircraft in close proximity. Accordingly, the Board concluded that the cause of the Airprox was a late sighting by the Tutor pilot and a possible a non-sighting by the Europa pilot. Notwithstanding the pilots' own responsibilities, the Board also agreed that the fact that ATC had not passed timely Traffic Information to the Tutor pilot when he was under a Traffic Service was a contributory factor. Turning to the risk, the Board noted that although the Europa pilot had not seen the Tutor and the Tutor pilot only obtained a late sighting of the Europa, the Tutor pilot did have time to wing-rock to acknowledge his sighting and could therefore have taken avoiding action if he had considered it necessary. As a result, the Board judged that although safety had been degraded, there had been no risk of a collision and the Airprox was therefore assessed as risk Category C.
