**AIRPROX REPORT No 2016221**

Date: 10 Oct 2016 Time: 1244Z Position: 5130N 00043W Location: 8.5nm W Heathrow

**PART A: SUMMARY OF INFORMATION REPORTED TO UKAB**

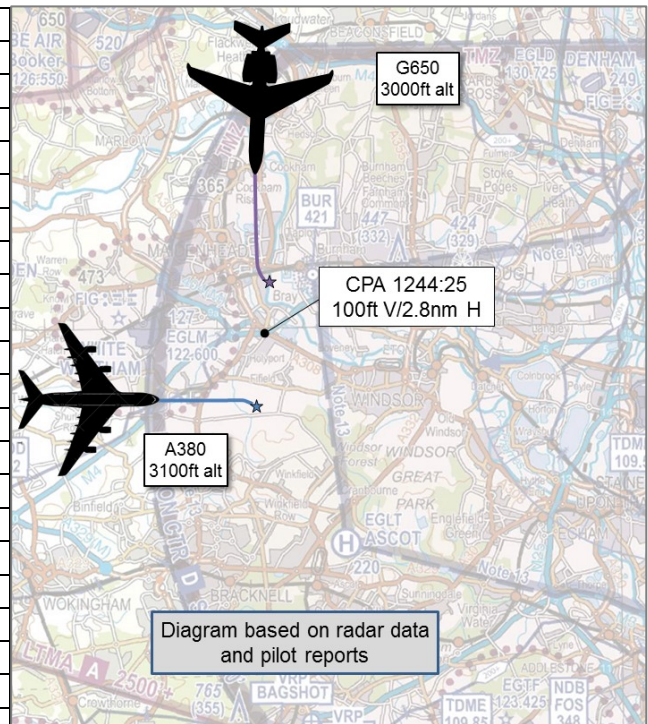
Recorded	Aircraft 1	Aircraft 2
Aircraft	A380	G650
Operator	CAT	Civ Comm
Airspace	London TMA	London TMA
Class	A	A
Rules	IFR	IFR
Service	Radar Control	Radar Control
Provider	Heathrow APP	Northolt APP
Altitude/FL	3100ft	3000ft
Transponder	A,C,S	A,C,S
Reported		
Colours	Company	NK
Lighting	Standard + Logo	NK
Conditions	VMC	VMC
Visibility	NK	NK
Altitude/FL	3000ft	1800ft
Altimeter	QNH	QNH
Heading	090°	NK
Speed	160kt	160kt
ACAS/TAS	TCAS II	TCAS I
Alert	None	None
Separation		
Reported	Not seen	NK V/2.7nm H
Recorded	100ft V/2.8nm H
