AIRPROX REPORT No 2016230

Date: 20 Oct 2016 Time: 1216Z Position: 5051N 00314W Location: Dunkeswell ATZ

PART A: SUMMARY OF INFORMATION REPORTED TO UKAB

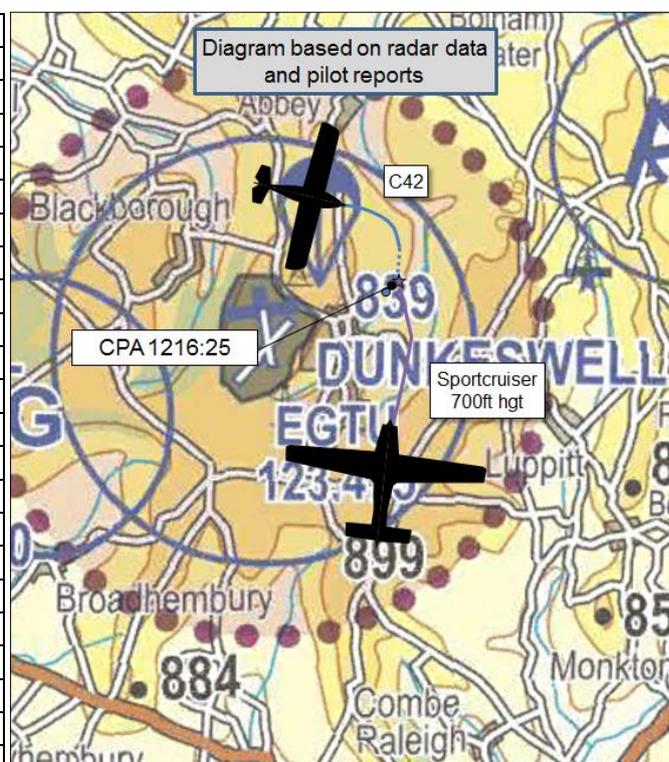
THE C42 PILOT reports that he had completed 3 circuits with his student on RW35R when they heard a call that sounded like 'you are going the wrong way'. An aircraft had called to say that he was using RW04 for operational reasons, the wind was 360° 10kts. He believes that at this time there was a Cessna on right base for RW35R, an aircraft on final for RW04R and a third aircraft holding off. His student called 'Downwind 35 right' and he was trying to explain to the student the position of the other aircraft and why one of them may need to use RW04R. He then looked ahead and saw an aircraft head-on at the same height, about 300m ahead. He pulled hard on the stick to avoid the plane, which passed underneath by about 30ft. He believes that had he not pulled up the aircraft would have collided.
