**AIRPROX REPORT No 2015002**

Date: 16 Jan 2015 Time: 1440Z Position: 5140N 00203W Location: Kemble Airfield

**PART A: SUMMARY OF INFORMATION REPORTED TO UKAB**

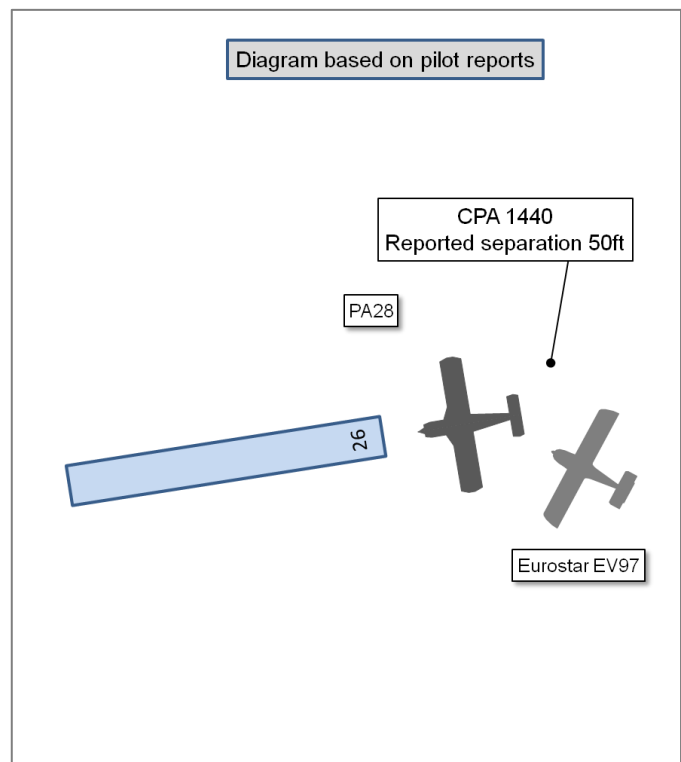
An Airprox was reported on 16 Jan 2015 at 1440 between a PA28 and a Eurostar EV97. Both aircraft were in the Kemble visual circuit, the PA28 was short finals to land when the EV97 was advised to go around; as he did so he passed over the top of the PA28, which he did not see.

Cause: The EV97 pilot flew into conflict with the PA28, which he did not see.
