AIRPROX REPORT No 2015089

Date: 28 May 2015 Time: 1350Z Position: 5109N 00259W Location: 1nm N Bridgewater

PART A: SUMMARY OF INFORMATION REPORTED TO UKAB

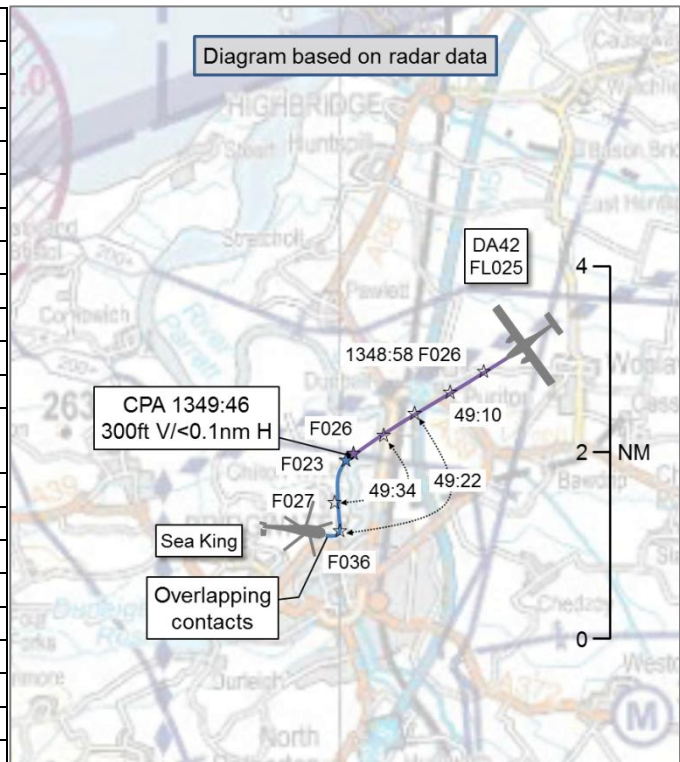
Recorded	Aircraft 1	Aircraft 2
Aircraft	Sea King	DA42
Operator	HQ JHC	Civ Trg
Airspace	London FIR	London FIR
Class	G	G
Rules	VFR	VFR
Service	Traffic	Basic
Provider	Yeovil Approach	Yeovil LARS
Altitude/FL	↓2200ft	2600ft
Transponder	A, C, S	A, C, S
Reported		
Colours	Green	White/blue
Lighting	Strobe, nav, nose spotlight	NK
Conditions	VMC	VMC
Visibility	25km	NK
Altitude/FL	↓3000ft	2500ft
Altimeter	RPS (1011hPa)	RPS (1011hPa)
Heading	360°	218°
Speed	100kt	140kt
ACAS/TAS	Not fitted	NK
Alert	N/A	Unknown
Separation		
Reported	0ft V/400m H	Not seen
Recorded	300ft V/<0.1nm H

THE SEA KING PILOT reports conducting an air test in the vicinity of Bridgewater, in a right turn through north at 5000ft, when ATC called traffic 5nm northeast, 2000ft below. The call was acknowledged, but neither pilot could see the traffic. The Handling Pilot (HP) thought that ATC had reported the traffic as tracking southeast. He elected to continue the right turn through 270° to roll out on west in preparation for a low-speed autorotation test profile, leading directly into a second autorotation test profile, thinking that the reported traffic would be well clear astern and tracking away. During the turn the aircraft was climbed to 5500ft to check the radar altimeter 'OFF flag' and the area below and to the right (north) of the aircraft was cleared in preparation for the autorotation. The aircraft was established in a low-speed autorotation and yawed 90° to the right iaw the test schedule. The HP then selected and held 20° nose down to accelerate to 100kt; the rate of descent was in the region of 3000fpm. The HP had just raised the nose to about 5° nose down, and stabilised the aircraft at 100kt, when ATC called traffic 1nm north, 200ft below. A white, slender-winged, twin-engined aircraft was seen slightly low in the 1 o'clock, belly up to the Sea King in a turn to the right, crossing rapidly right-to-left. Although the conflicting traffic was initially slightly below the Sea King, both pilots were looking down and ahead into the autorotation flight path and had to look up to see the conflicting traffic. In addition, in the moments before the Airprox, both pilots had increased their scan of the rotor rpm-gauge as the aircraft was flared in autorotation. It was not possible to determine if the conflicting aircraft was climbing or descending. The HP initiated a turn to the right, although the confliction had passed before the aircraft responded. CPA was assessed to be as the Sea King descended through the level of the other aircraft. The Non-Handling Pilot (NHP) assessed the minimum separation to be 600m; the HP thought it was closer, perhaps as little as 250m. The aircraft was recovered to level flight at 2500ft and the right turn was continued in an effort to regain visual with the conflicting traffic but it could not be seen. An Airprox was reported to ATC and the sortie continued. The pilot noted that the Sea King crew assumed that the conflicting traffic was that initially reported at 5nm northeast. The pilots did not see the conflicting traffic in time to make any

effective contribution to avoiding a collision. However, since the conflicting traffic was seen to be taking appropriate action, the perceived severity was assessed as Medium.
