AIRPROX REPORT No 2014007

Date/Time: 27 Jan 2014 1256z

Position: 5536N 00125W
(55 ne Newcastle)

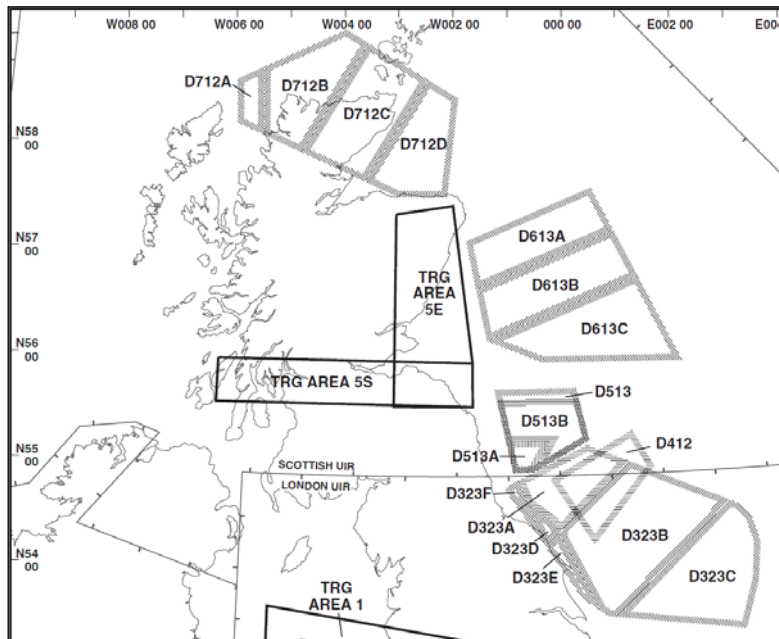
Figure 1: Managed Danger Areas.

This incident occurred between a formation of 2 Hawks and a Falcon FA20. All aircraft were under a Radar Control Service followed by a Traffic Service from the same WC. Due to the sea state, the exercise was moved from D613 to above D513, as per Figure 1. Levels required for deconfliction had been pre-briefed, and the SOP is for the crews to be cleared into a block and an operating area for the mission.
