PART A: SUMMARY OF INFORMATION REPORTED TO UKAB

An Airprox was reported between a Merlin and a PA28 on 30 April 2014 at 1545. The Merlin received Traffic Information from Benson ATC, although it is unclear whether this was in fact on the PA28, and then switched to Luton for a listening watch. The PA28 was receiving a Basic Service from Farnborough LARS (North).

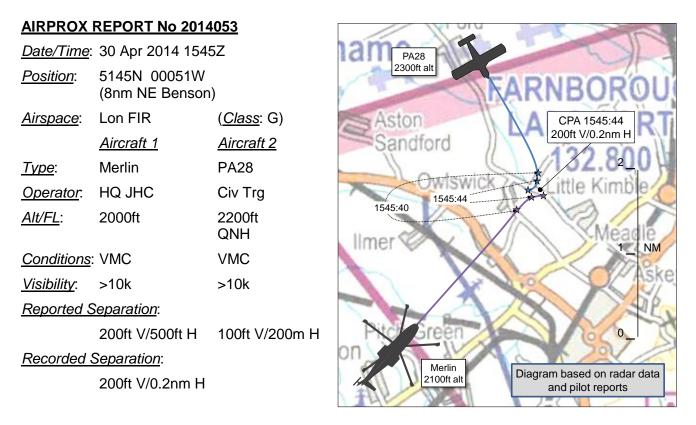
THE MERLIN PILOT reports flying a green aircraft with all lights illuminated and transponder Modes 3A, C and S selected. Whilst transiting north of Benson and receiving a Basic Service from Benson ATC, the controller provided Traffic Information on traffic to the north of the Merlin's position. The crew looked out and a fixed-wing aircraft was spotted. The non-handling pilot then switched frequency to Luton Radar. The fixed-wing aircraft was tracking very slowly from left to right in the windscreen and was assessed as being on a constant bearing. Being on the right of the fixed-wing aircraft, the crew expected it to give way to them and to turn behind. However, no adjustment to the fixed-wing's course was noted, and a decision was made to turn left and go behind it instead. At the same time as the left turn was initiated, the light aircraft broke right towards the Merlin. An evasive right break and descent was immediately conducted by the Merlin HP, and the other aircraft passed high and to the left.

THE PA28 PILOT reports flying a predominately white aircraft with strobes and landing light on and transponder modes 3A and C selected. He was flying on a solo nav-ex and receiving a Basic Service from Farnborough LARS North. He briefly went off frequency, with the knowledge of the controller, to give Turwestern a courtesy call as he turned in their overhead. When in the vicinity of Princes Risborough, he saw a helicopter in his 3 o'clock, on a converging path and at a similar height. He immediately executed a turn to the right to give way to the other aircraft. After commencing the turn, the other aircraft also made a turn to the right. Once clear he resumed his original course, he did not recall receiving any traffic information from ATC.

The Board agreed that the cause of the Airprox was a late sighting by the PA28 pilot, with a contributory factor that the Merlin crew did not manoeuvre earlier to break the conflict. The Board assessed the risk as B, safety margins had been reduced below the normal.
