AIRPROX REPORT No 2022015

Date: 09 Feb 2022 Time: 1017Z Position: 5248N 00240W Location: RAF Shawbury – elev 248ft

PART A: SUMMARY OF INFORMATION REPORTED TO UKAB

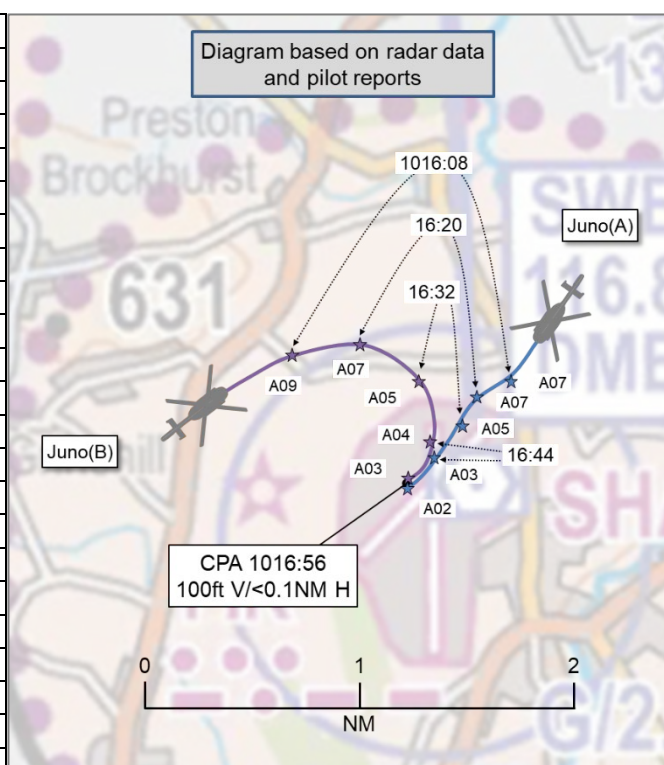
Recorded	Aircraft 1	Aircraft 2
Aircraft	Juno ¹ (A)	Juno (B)
Operator	HQ Air (Trg)	HQ Air (Trg)
Airspace	Shawbury ATZ	Shawbury ATZ
Class	G	G
Rules	VFR	VFR
Service	ACS	ACS
Provider	Shawbury Tower	Shawbury Tower
Altitude/FL	300ft	300ft
Transponder	A, C, S+	A, C, S+
Reported		
Colours	Black, yellow	Black, yellow
Lighting	Anti-col, nav, HISL	NK
Conditions	VMC	VMC
Visibility	>10km	NK
Altitude/FL	150ft	500ft
Altimeter	QFE (1013hPa)	NK
Heading	230°	NK
Speed	30kt	NK
ACAS/TAS	TAS	NK ²
Alert	Unknown	Unknown
Separation at CPA		
Reported	0ft V/50-70m H	Not assessed
Recorded	0ft V/<0.1NM H
