## AIRPROX REPORT No 2022030

Date: 14 Mar 2022 Time: 1531Z Position: 5159N 00118W Location: 3NM NW of Upper Heyford

### PART A: SUMMARY OF INFORMATION REPORTED TO UKAB

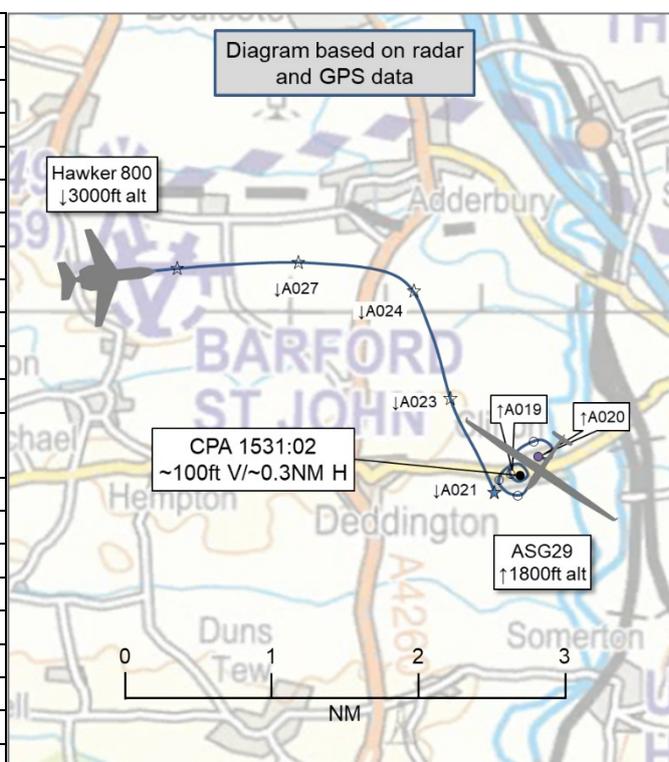
Recorded	Aircraft 1	Aircraft 2
Aircraft	Hawker 800	ASG29
Operator	Civ Comm	Civ Gld
Airspace	London FIR	London FIR
Class	G	G
Rules	IFR	VFR
Service	Traffic	None
Provider	Oxford Radar	N/A
Altitude/FL	2100ft	2000ft
Transponder	A, C, S+	Not fitted
Reported		
Colours	White, grey	White
Lighting	Nav, beacon, taxi, strobes	None
Conditions	VMC	VMC
Visibility	>10km	>10km
Altitude/FL	1800ft	1700ft
Altimeter	QNH (1023hPa)	QFE (NK hPa)
Heading	170°	'SE'
Speed	150kt	70kt
ACAS/TAS	TCAS II	PowerFLARM
Alert	None	None
Separation at CPA		
Reported	0ft V/100-200m H	Not Seen
Recorded	~100ft V/~0.3NM H <sup>1</sup>

<sup>1</sup> CPA derived from a comparison of radar data for the Hawker 800 and GPS data for the ASG29.
