**AIRPROX REPORT No 2022114**

Date: 22 Jun 2022 Time: 1552Z Position: 5110N 00106W Location: 3NM SW Lasham

**PART A: SUMMARY OF INFORMATION REPORTED TO UKAB**

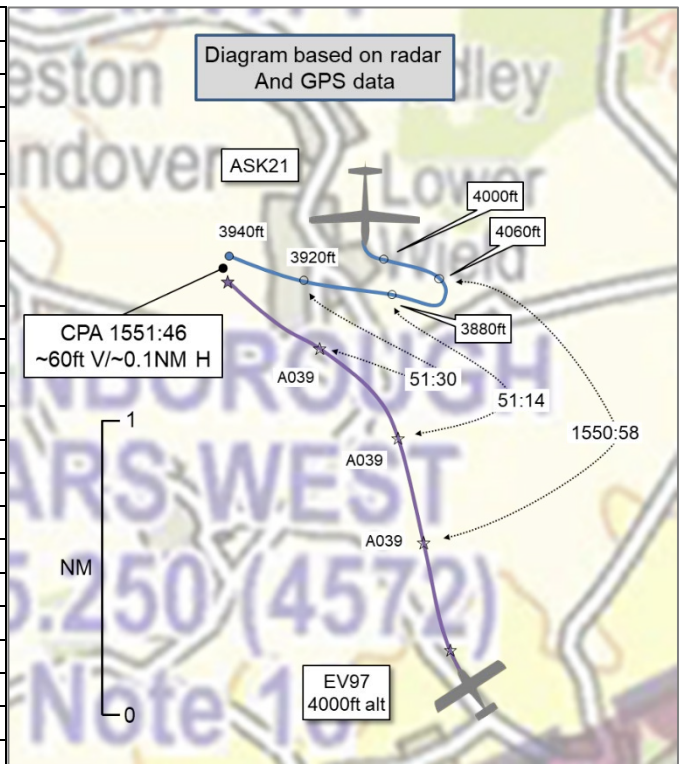
Recorded	Aircraft 1	Aircraft 2
Aircraft	ASK21	EV97
Operator	Civ Gld	Civ FW
Airspace	London FIR	London FIR
Class	G	G
Rules	VFR	VFR
Service	None	Basic
Provider	N/A	Farnborough LARS West
Altitude/FL	3940ft	4000ft
Transponder	Not fitted	A, C
<b>Reported</b>		
Colours	White, Orange	'Aluminium', Blue
Lighting	None	None
Conditions	VMC	VMC
Visibility	>10km	>10km
Altitude/FL	2800ft	4000
Altimeter	QFE (NK hPa)	QNH (NK hPa)
Heading	'North'	~350°
Speed	50kt	78kt
ACAS/TAS	FLARM	PilotAware
Alert	None	None
<b>Separation at CPA</b>		
Reported	100ft V/0m H	Not Seen
Recorded	~60ft V/~0.1NM H

**THE ASK21 PILOT** reports that they were heading north at 2800ft on Lasham QFE. The threat aircraft overflew them on the same heading, directly overhead and approximately 100ft above.

At 1552:24, [the EV97] could be seen on radar 3NM west-southwest of Lasham, tracking northwest-bound, and was observed to overfly a primary return, which was seen on the Heathrow Green, they got within 0.02NM, height unknown.
