AIRPROX REPORT No 2022165

Date: 07 Aug 2022 Time: 0931Z Position: 5312N 00116W Location: 4NM NW Mansfield

PART A: SUMMARY OF INFORMATION REPORTED TO UKAB

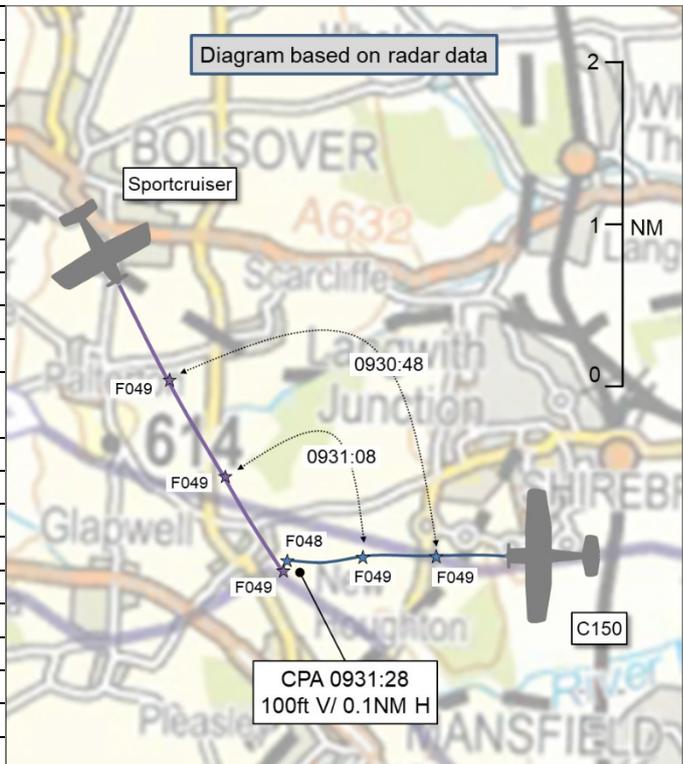
Recorded	Aircraft 1	Aircraft 2
Aircraft	CSA Sportcruiser	C150
Operator	Civ FW	Civ FW
Airspace	London FIR	London FIR
Class	G	G
Rules	VFR	VFR
Service	None	None
Altitude/FL	FL049	FL048
Transponder	A, C, S	A, C
Reported		
Colours	Blue, white	Blue, white
Lighting	Strobes	Beacon, Strobes, Nav, Landing
Conditions	VMC	VMC
Visibility	>10km	>10km
Altitude/FL	FL055	NK
Altimeter	NK	QNH (NK hPa)
Heading	150°	270°
Speed	105kt	105kt
ACAS/TAS	SkyEcho	Not fitted
Alert	None	N/A
Separation at CPA		
Reported	0ft V/300m H	50ft V/0.25NM H
Recorded	100ft V/0.1NM H
