## AIRPROX REPORT No 2022254

Date: 18 Oct 2022 Time: 0930Z Position: 5336N 00032W Location: 7NM WNW Humberside

### PART A: SUMMARY OF INFORMATION REPORTED TO UKAB

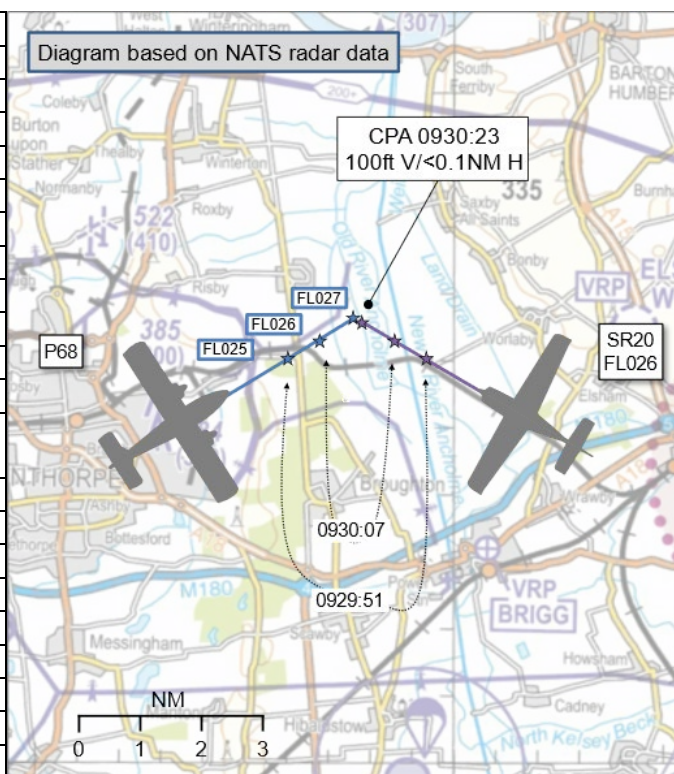
Recorded	Aircraft 1	Aircraft 2
Aircraft	P68	SR20
Operator	Civ Comm	Civ FW
Airspace	London FIR	London FIR
Class	G	G
Rules	VFR	VFR
Service	Basic	Traffic
Provider	Humberside	Humberside
Altitude/FL	3100ft	3000ft
Transponder	A, C, S	A, C, S
<b>Reported</b>		
Colours	White, Blue	White
Lighting	Nav, Beacon, Strobe	Strobes
Conditions	VMC	VMC
Visibility	>10km	>10km
Altitude/FL	3140ft	3000ft
Altimeter	QNH	QNH
Heading	055°	300°
Speed	125kt	135kt
ACAS/TAS	TAS	TAS
Alert	None	TA
<b>Separation at CPA</b>		
Reported	140ft V/0m H	500ft V/0m H
Recorded	100ft V/<0.1NM H
