**AIRPROX REPORT No 2023007**

Date: 20 Jan 2023 Time: ~1542Z Position: 5430N 00540W Location: 5NM S Newtownards

**PART A: SUMMARY OF INFORMATION REPORTED TO UKAB**

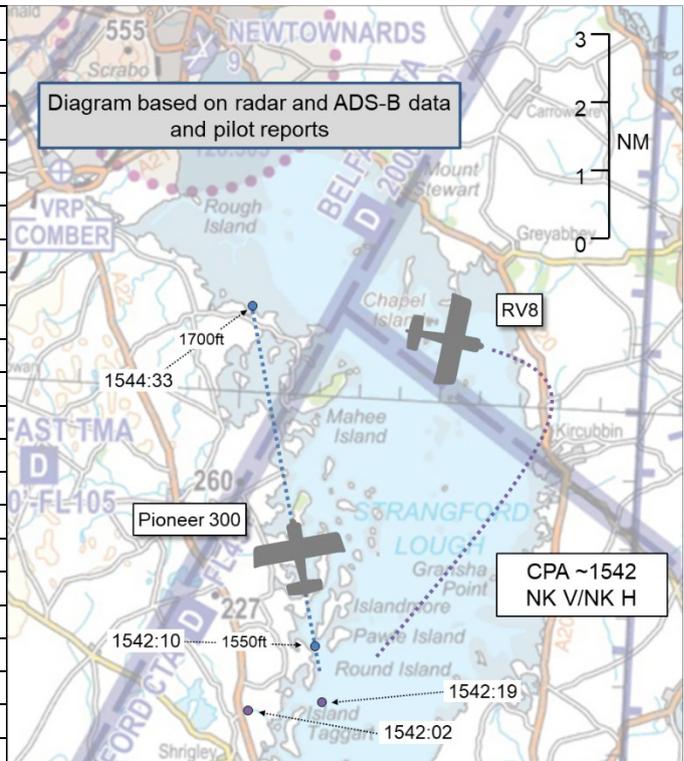
**THE PIONEER 300 PILOT** reports that they were 7.5NM south of Newtownards, just approaching a place called Mahee Island, at 1900ft. A black and grey RV8 came in front of them from left-to-right (10 o'clock to 2 o'clock) roughly from the Comber [VRP] direction and at approximately the same level. The RV8 crossed their path approximately 3.5NM in front of them. At this point there was no problem as they could see it and there was enough distance between them. When the RV8 got to their 2 o'clock, roughly around Greyabbey, it did a steep 180° turn and headed straight towards their 3 o'clock, the RV8 just seconds away from them. When very close to them, the RV8 went behind and they could not see it after that. They continued on to Newtownards and did an overhead approach to land. After landing and taxiing, the RV8 came in and landed.

The pilot of the Pioneer 300 reports that they had not taken avoiding action as the [RV8] had been at their 3 o'clock, so going straight on was the best option.
