AIRPROX REPORT No 2023038

Date: 03 Apr 2023 Time: 0920Z Position: 5135N 00109W Location: Wallingford, Oxfordshire

PART A: SUMMARY OF INFORMATION REPORTED TO UKAB

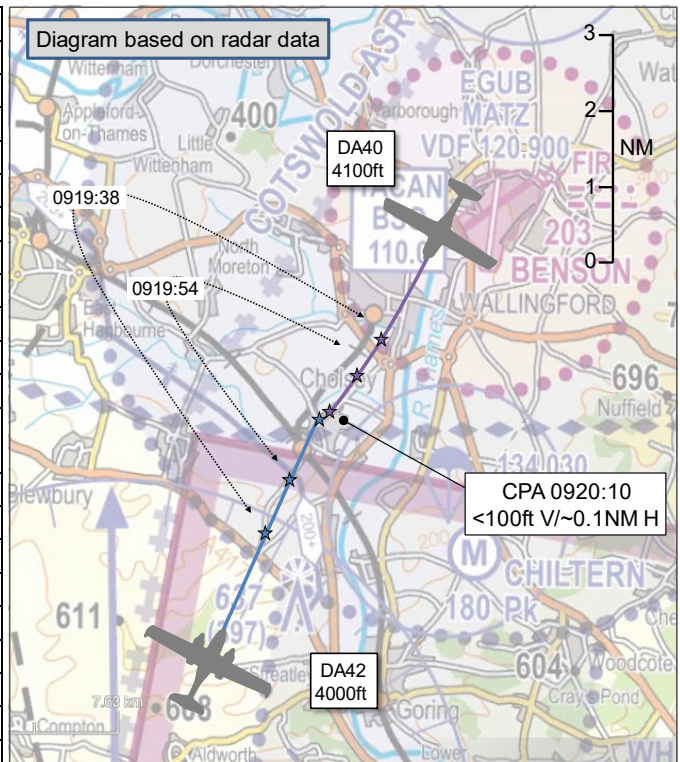
Recorded	Aircraft 1	Aircraft 2
Aircraft	DA42	DA40
Operator	Civ FW	Civ FW
Airspace	London FIR	London FIR
Class	G	G
Rules	IFR	IFR
Service	Basic	Traffic
Provider	Benson	Farnborough
Altitude/FL	4000ft	4100ft
Transponder	A, C, S	A, C, S
Reported		
Colours	White	White
Lighting	Position, Strobes, Landing	Landing, Nav, Strobes
Conditions	VMC	VMC
Visibility	>10km	>10km
Altitude/FL	4000ft	4000ft
Altimeter	QNH (1030hPa)	QNH
Heading	020°	205°
Speed	160kt	120kt
ACAS/TAS	TAS	PilotAware
Alert	Information	Information
Separation at CPA		
Reported	30ft V/100m H	30ft V/200m H
Recorded	<100ft V/~0.1NM ¹ H
