AIRPROX REPORT No 2023068

Date: 30 Apr 2023 Time: 0745Z Position: 5105N 00033W Location: 2NM SW Dunsfold

PART A: SUMMARY OF INFORMATION REPORTED TO UKAB

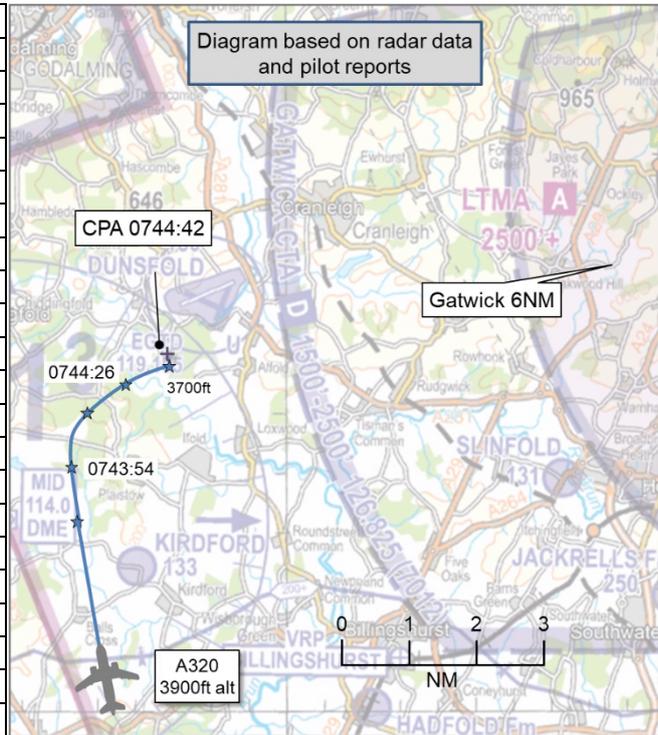
THE A320 PILOT reports talking to Gatwick Director as they had been descending to 5000ft on a downwind for RW08R, they had been informed of a hot air balloon south of the final approach track at approximately 3000ft. The pilot became visual with the balloon as they descended to 4000ft and turned onto a base heading of 355° for an approximately 12NM final. They remained visual with the balloon noting that it looked like it had been drifting north with the wind; the A320 pilot had been given a heading of 055° to intercept final approach, descent to 3000ft and cleared ILS. The A320 pilot maintained visual with the balloon at all times. As the A320 pilot captured the localiser it became clear the balloon had been on the final approach track so deemed it unsafe to continue; the A320 pilot estimated the balloon to have been 1NM ahead of them. The A320 pilot took a heading of south and climbed back up to 4000ft and retracted flaps. Looking at the wind on the nav display, it appeared the balloon would be north of the final approach track by the time the A320 took a second approach. They took a right turn for a base leg, descended to 3000ft and could see the balloon also descending north of final approach. The A320 pilot considered it safe to continue a second approach which resulted in an uneventful landing. The balloon appeared to have been red in colour with [company brand] written on the side and it appeared to land at [destination airfield] at approximately 0755.

Analysis of the radar showed that a primary return had been displayed at 0732:42, which correlated with the approximate position the A320 pilot reported the Balloon to have been, however this return disappeared shortly after. No further related radar returns had been observed. It had not been possible to definitively correlate the radar return to the Balloon. The pilot of the aircraft following reported that the Balloon had been directly abeam them at 0735:14, which correlated to the approximate position of that primary return. The pilot added that it looked to them to be "more than 2000ft, perhaps 3000ft", the base of controlled airspace in the area in which the primary return had appeared is 2500ft. The pilot of a following aircraft gave position reports of the Balloon which suggested it to have been tracking in a NNW direction, towards the final approach track for RW08R at Gatwick, and gave altitude reports ranging from 2500ft to above 3000ft.
